## LOG OF BORING AA-38

CLIENT: HDR Engineering, Inc.  
PROJECT: Galveston Anchorage Area C Sand Source Inv.  
LOCATION: Anchorage Area C, Galveston, Texas  
NUMBER: G109233

**PROJECT NAME:** Galveston Anchorage Area C Sand Source Investigation

## GRAIN SIZE DISTRIBUTION

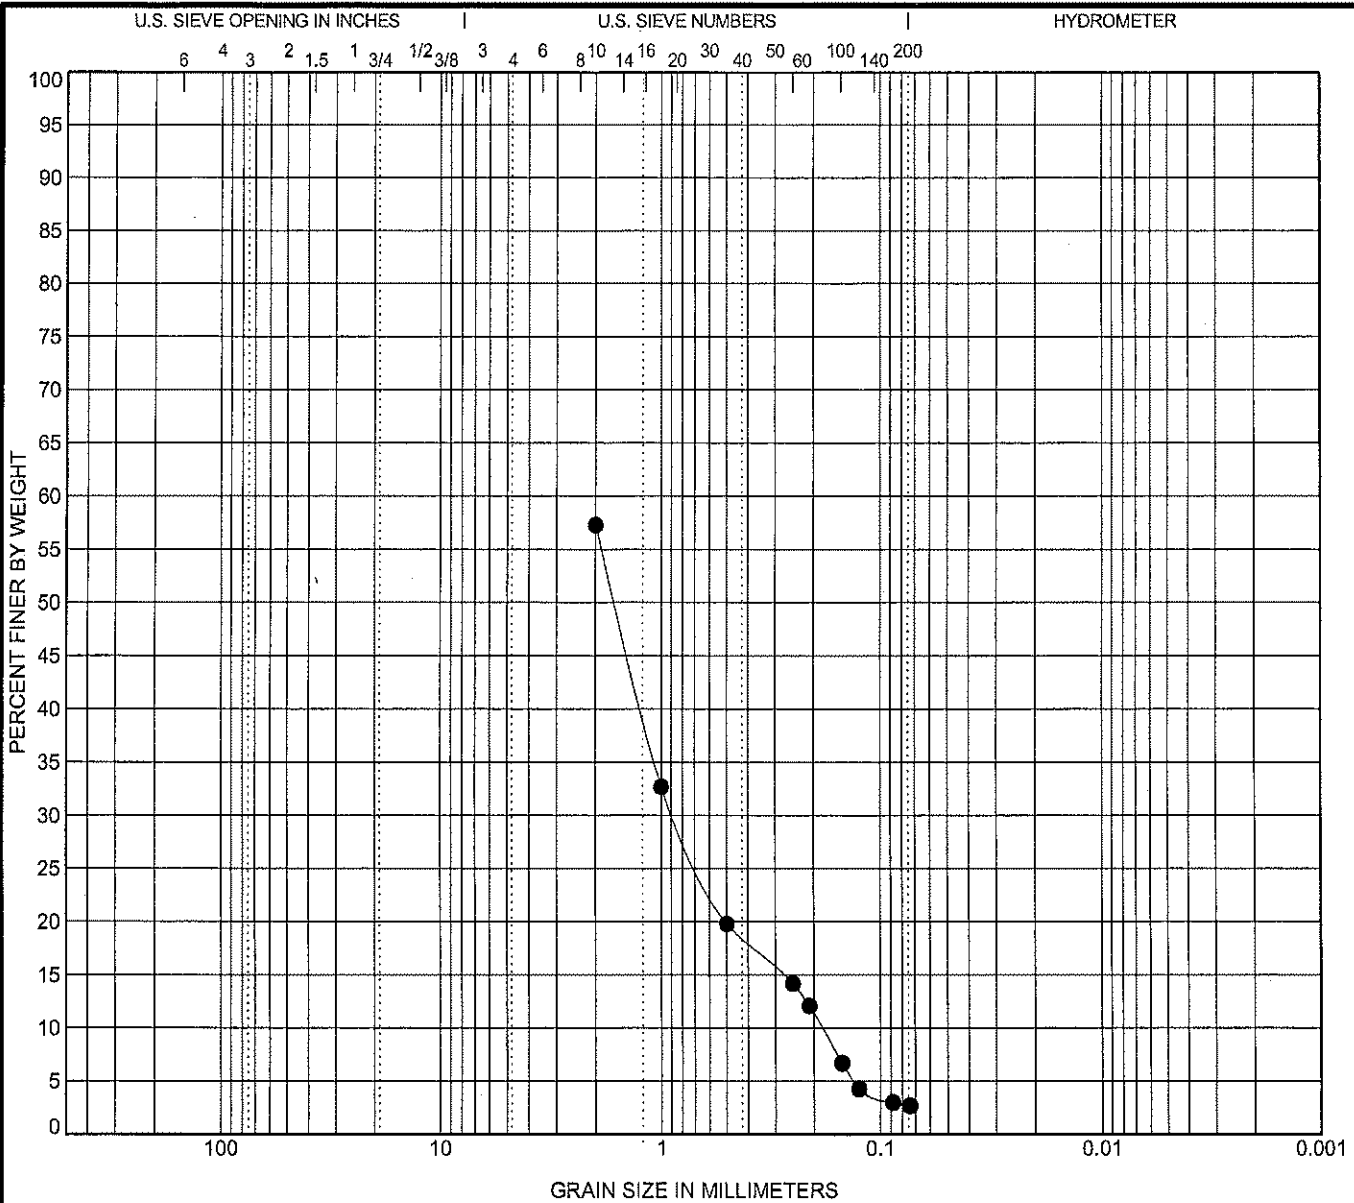
| Specimen ID | Depth | Classification | LL | PL | PI | Cc | Cu |
|---|---|---|---|---|---|---|---|
| ● AA-38 (-27.12' to -29.12' NAVD) | | AA-38 (-27.12' to -29.12' NAVD) | | | | | |

| Specimen ID | Depth | D100 | D60 | D30 | D10 | %Gravel | %Sand | %Silt | %Clay |
|---|---|---|---|---|---|---|---|---|---|
| ● AA-38 (-27.12' to -29.12' NAVD) | | 2 | | 0.865 | 0.184 | 0.0 | | | |

| PERCENT SHELL BY WEIGHT (BASED ON #10 SIEVE) | | | |
|---|---|---|---|
| 42.70 | 6.59 | 4.90 | 0.20 |

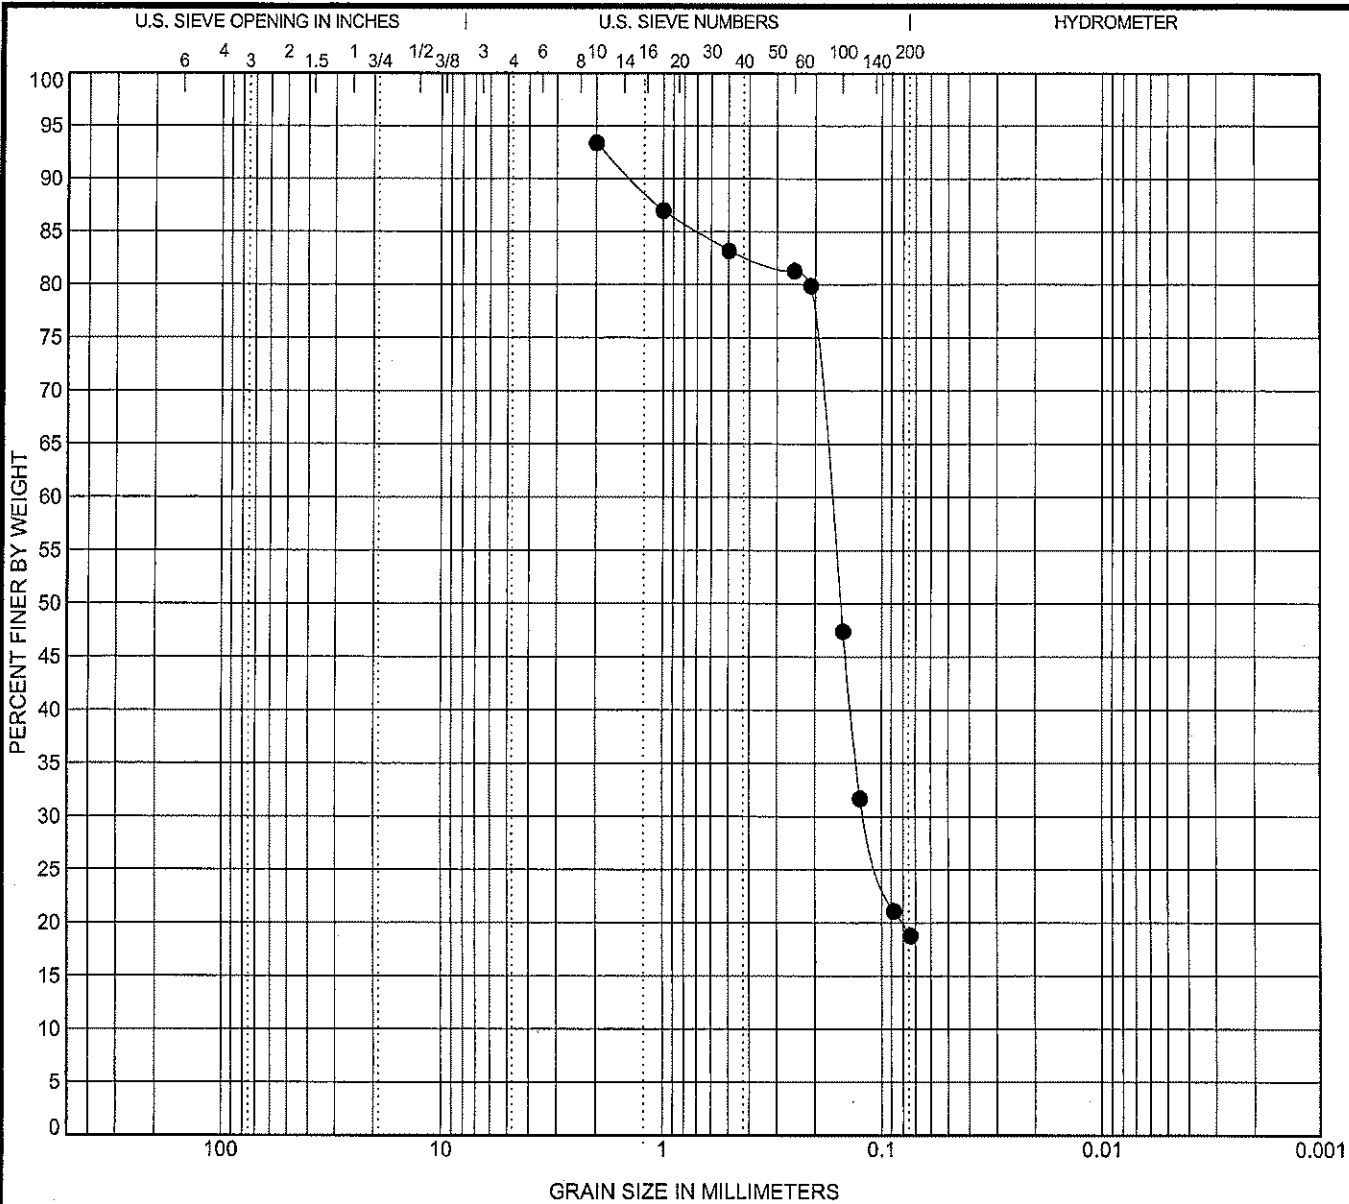
| Specimen ID | Depth | Classification | LL | PL | PI | Cc | Cu |
|---|---|---|---|---|---|---|---|
| ● AA-38 (-31.12' to -33.12' NAVD) | | AA-38 (-31.12' to -33.12' NAVD) | | | | | |

| Specimen ID | Depth | D100 | D60 | D30 | D10 | %Gravel | %Sand | %Silt | %Clay |
|---|---|---|---|---|---|---|---|---|---|
| ● AA-38 (-31.12' to -33.12' NAVD) | | 2 | 0.17 | 0.118 | | 0.0 | | | |

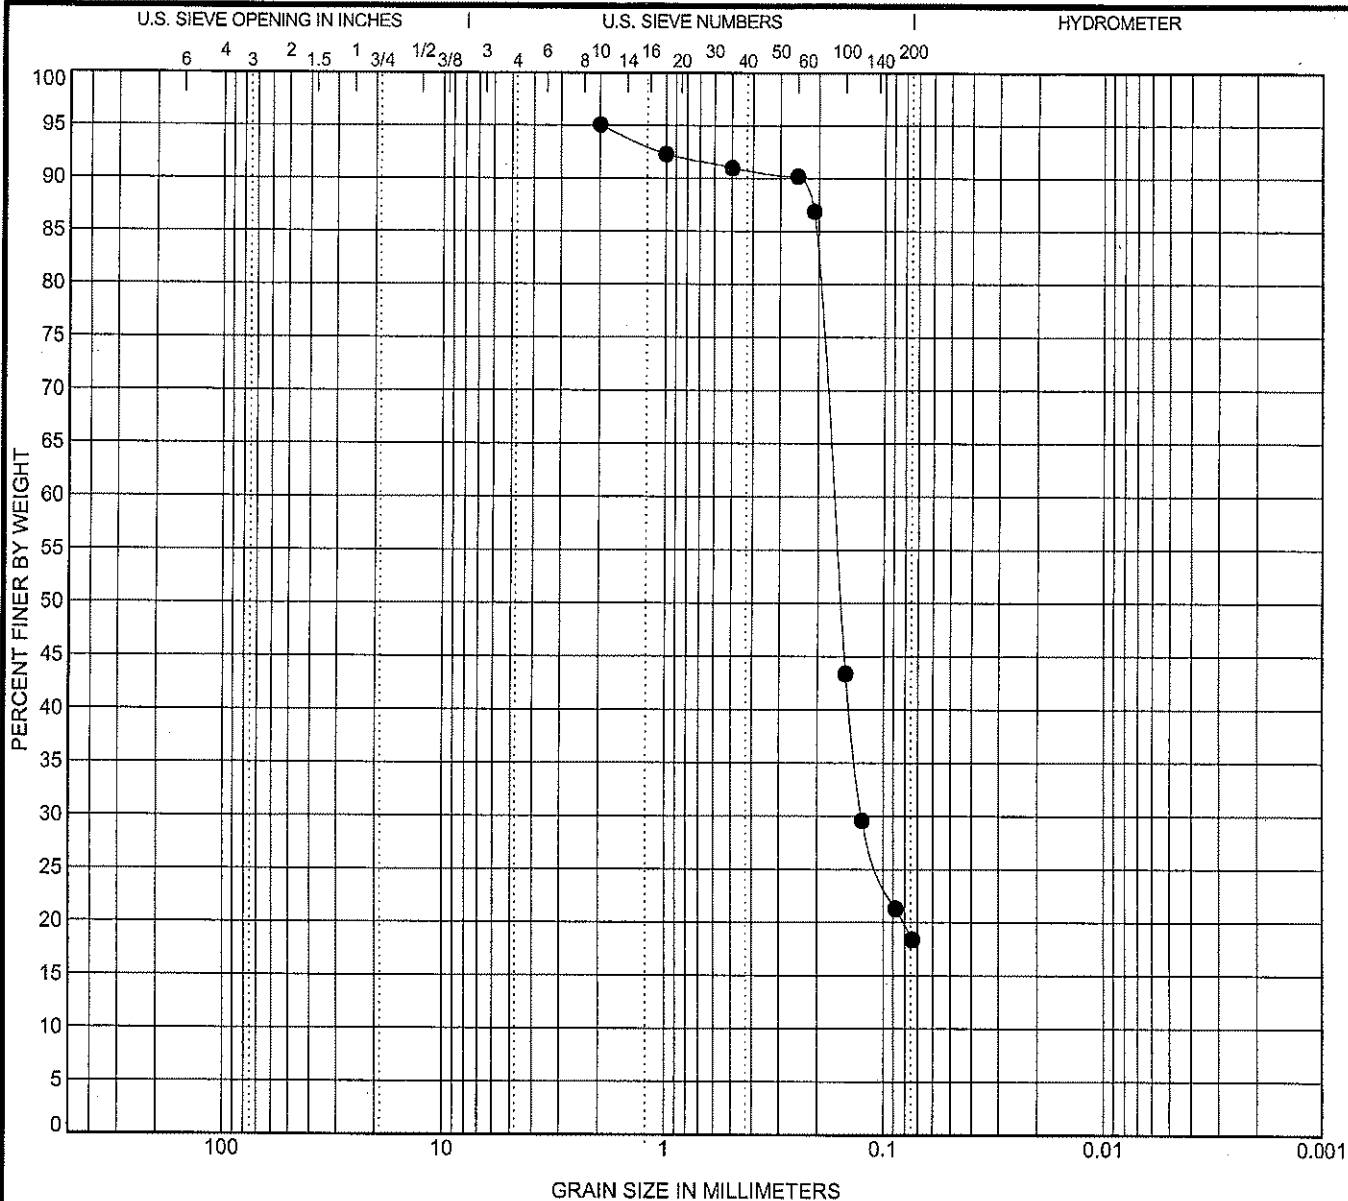
## GRAIN SIZE DISTRIBUTION

| Specimen ID | Depth | Classification | LL | PL | PI | Cc | Cu |
|---|---|---|---|---|---|---|---|
| ● AA-38 (-33.12' to -35.12' NAVD) | | AA-38 (-33.12' to -35.12' NAVD) | | | | | |

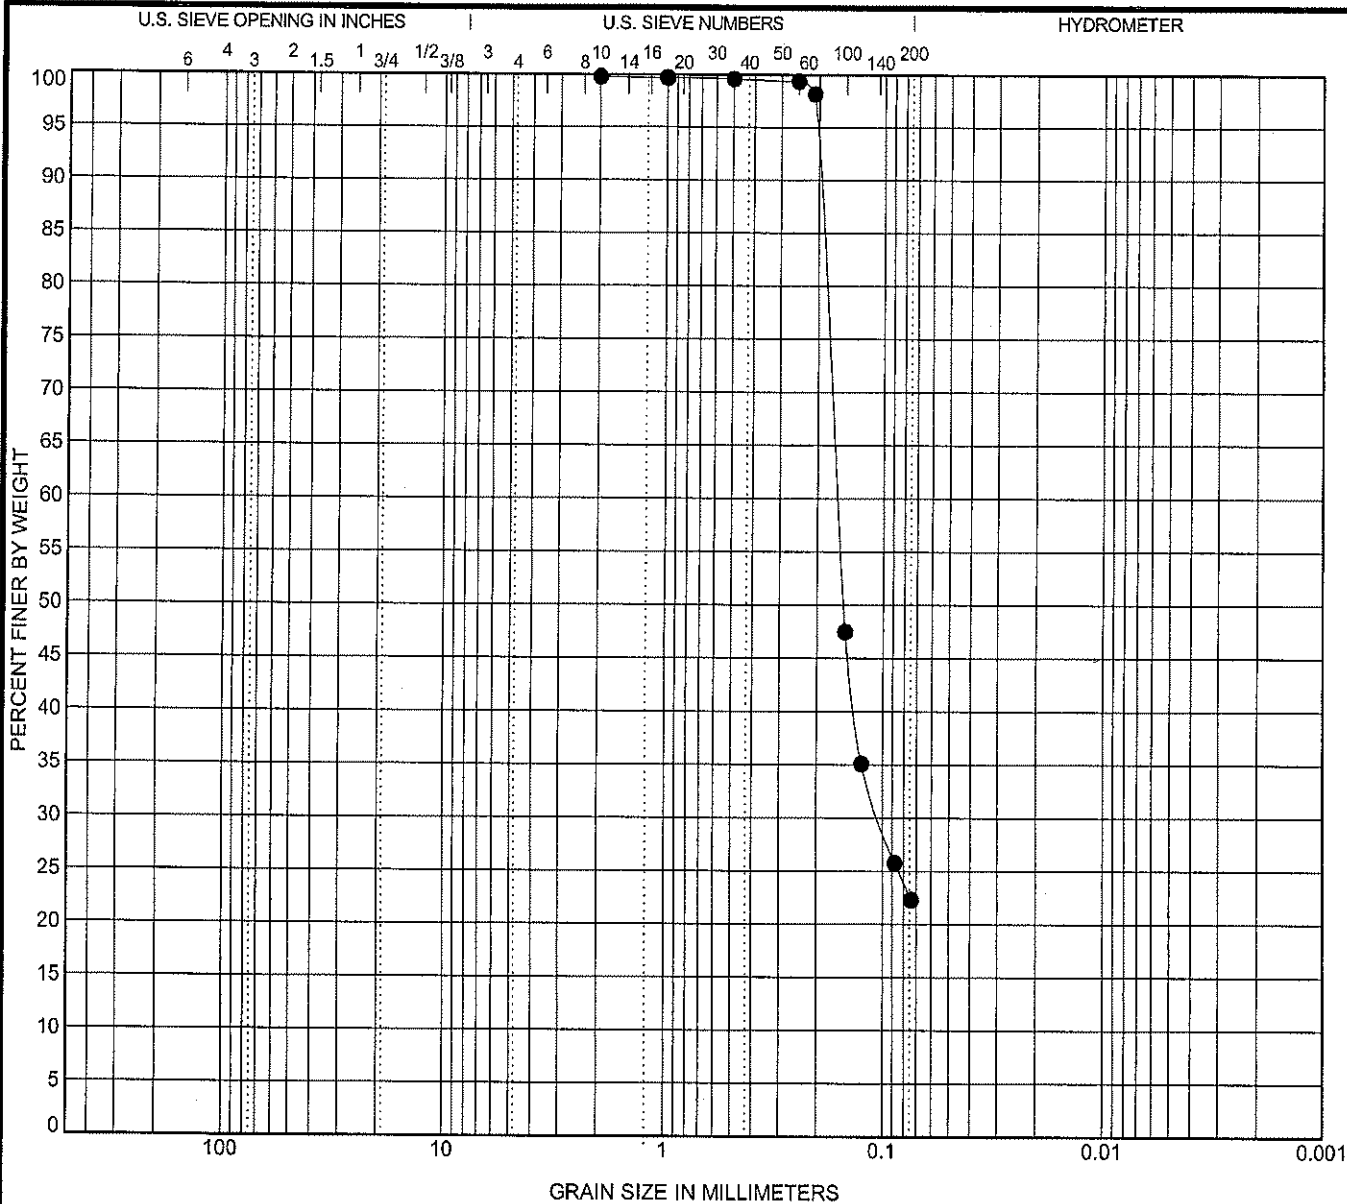
## GRAIN SIZE DISTRIBUTION

| Specimen ID | Depth | Classification | LL | PL | PI | Cc | Cu |
|---|---|---|---|---|---|---|---|
| ● AA-38 (-35.12' to -37.12' NAVD) | | AA-38 (-35.12' to -37.12' NAVD) | | | | | |

| Specimen ID | Depth | D100 | D60 | D30 | D10 | %Gravel | %Sand | %Silt | %Clay |
|---|---|---|---|---|---|---|---|---|---|
| ● AA-38 (-35.12' to -37.12' NAVD) | | 2 | 0.162 | 0.103 | | 0.0 | | | |

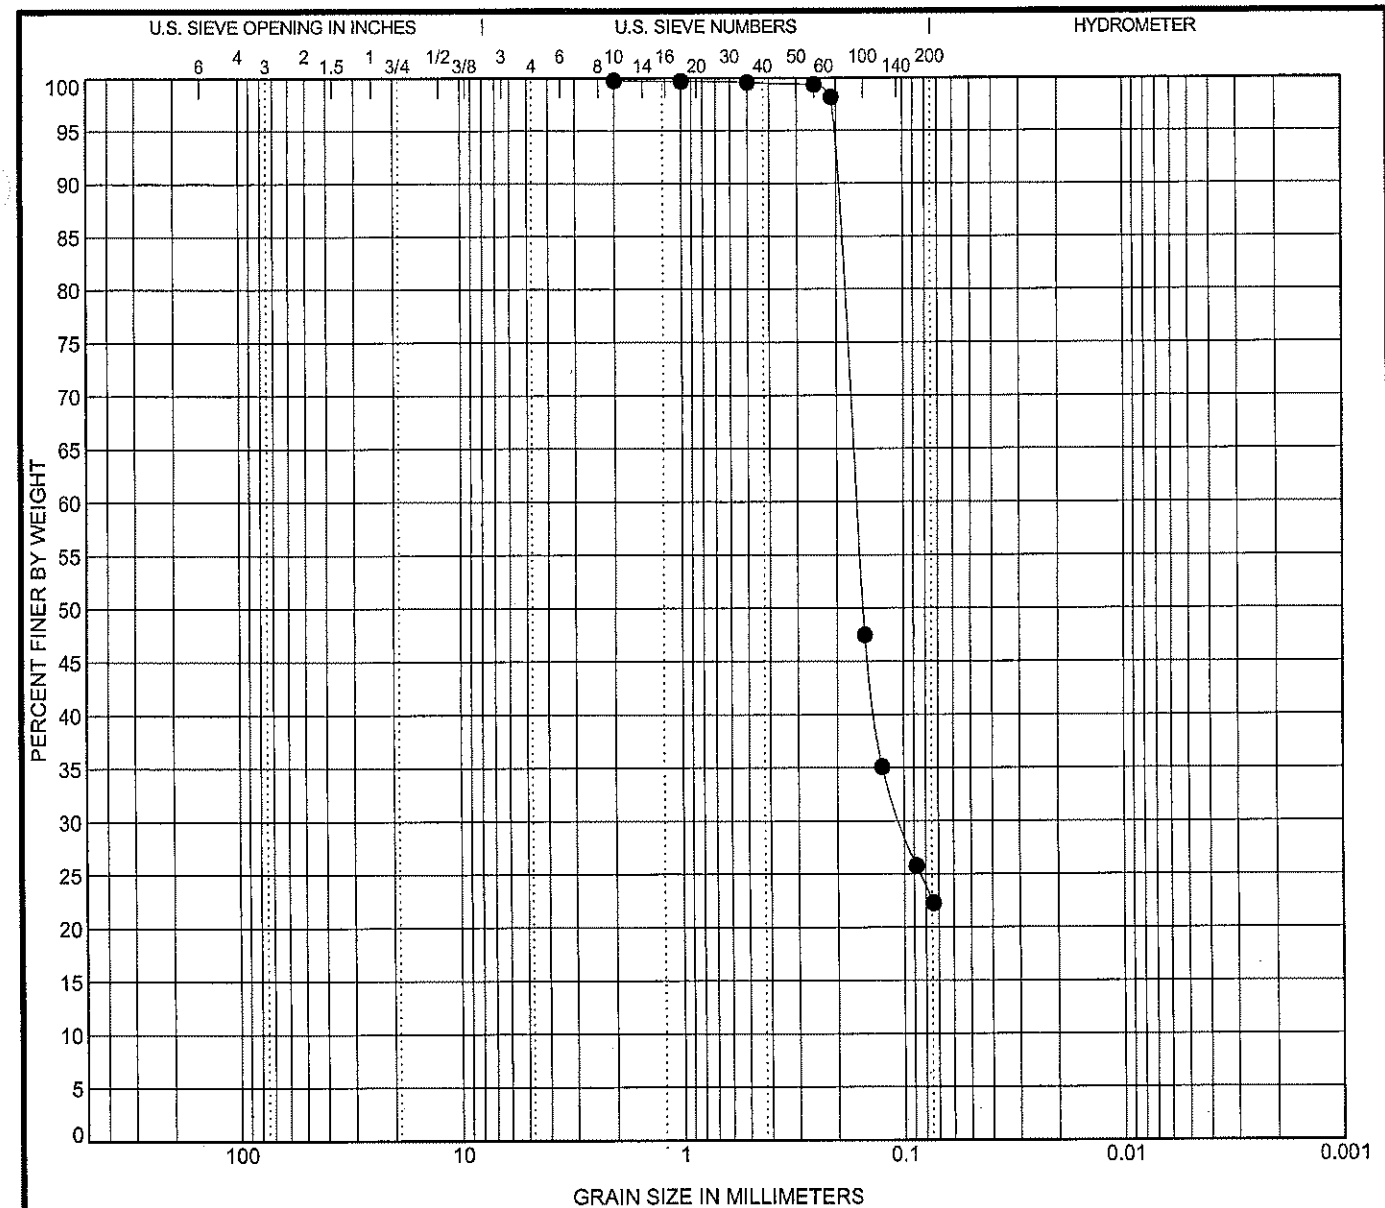
## GRAIN SIZE DISTRIBUTION

| Specimen ID | Depth | Classification | LL | PL | PI | Cc | Cu |
|---|---|---|---|---|---|---|---|
| ● AA-38 (-35.12' to -37.12' NAVD) | | AA-38 (-35.12' to -37.12' NAVD) | | | | | |

| Specimen ID | Depth | D100 | D60 | D30 | D10 | %Gravel | %Sand | %Silt | %Clay |
|---|---|---|---|---|---|---|---|---|---|
| ● AA-38 (-35.12' to -37.12' NAVD) | | 2 | 0.162 | 0.103 | | 0.0 | | | |
