PRELIMINARY INVESTIGATIONS OF SUBMERGED AREAS

Project ANW Refuge

Location ID Number J-26

**Project:** Aransas National Wildlife Ref. - BUS Site "J"  
**Location:** Dunham Bay located outside of Rockport, TX  
**Delivery Order #:** 0023  
**Date of Testing:** 10/20/04 to 10/22/04

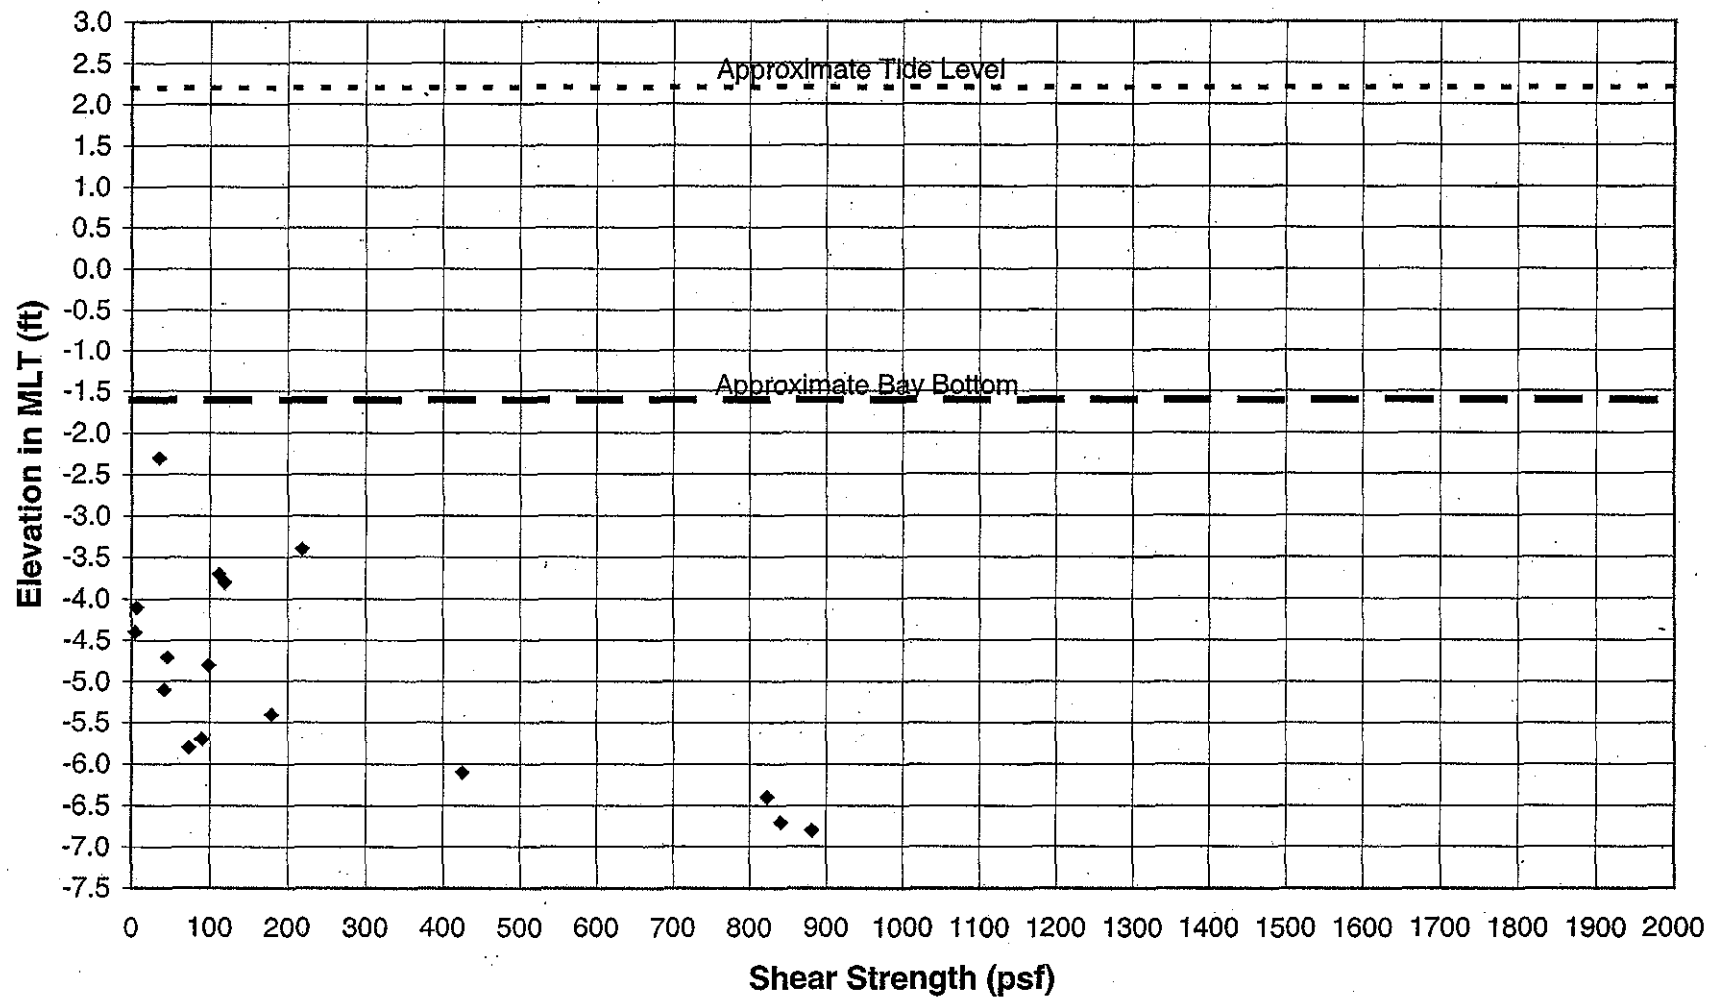
♦ J26

# Depth Vs. Shear Strength
