# PRELIMINARY INVESTIGATIONS OF SUBMERGED AREAS

Project A N W Refuge

**Project:** Aransas National Wildlife Ref. - BUS Site "J"  
**Location:** Dunham Bay located outside of Rockport, TX  
**Delivery Order #:** 0023  
**Date of Testing:** 10/20/04 to 10/22/04

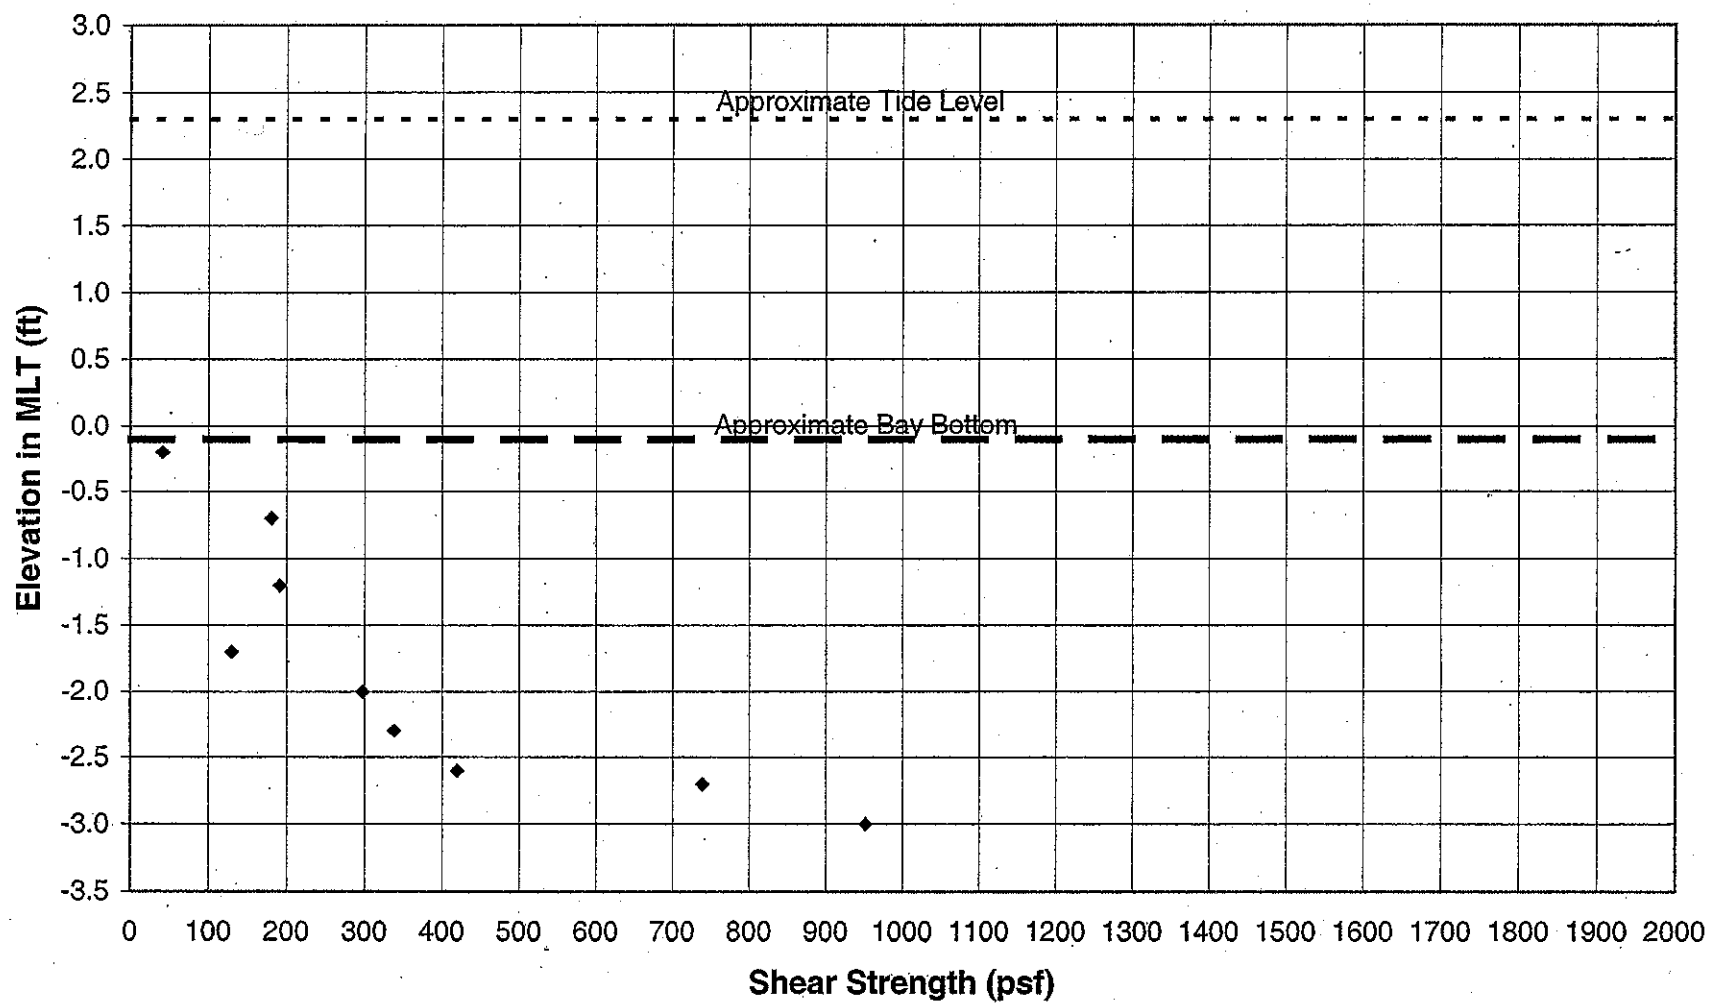
# Depth Vs. Shear Strength

♦ J16

### Hand Cone Penetrometer Test and Analysis:
