PRELIMINARY INVESTIGATIONS OF SUBMERGED AREAS

Delivery Order Number 023 Date 10/20/04  
Project ANW Refuge

Location ID Number J-13

**Project:** Aransas National Wildlife Ref. - BUS Site "J"  
**Location:** Dunham Bay located outside of Rockport, TX  
**Delivery Order #:** 0023  
**Date of Testing:** 10/20/04 to 10/22/04

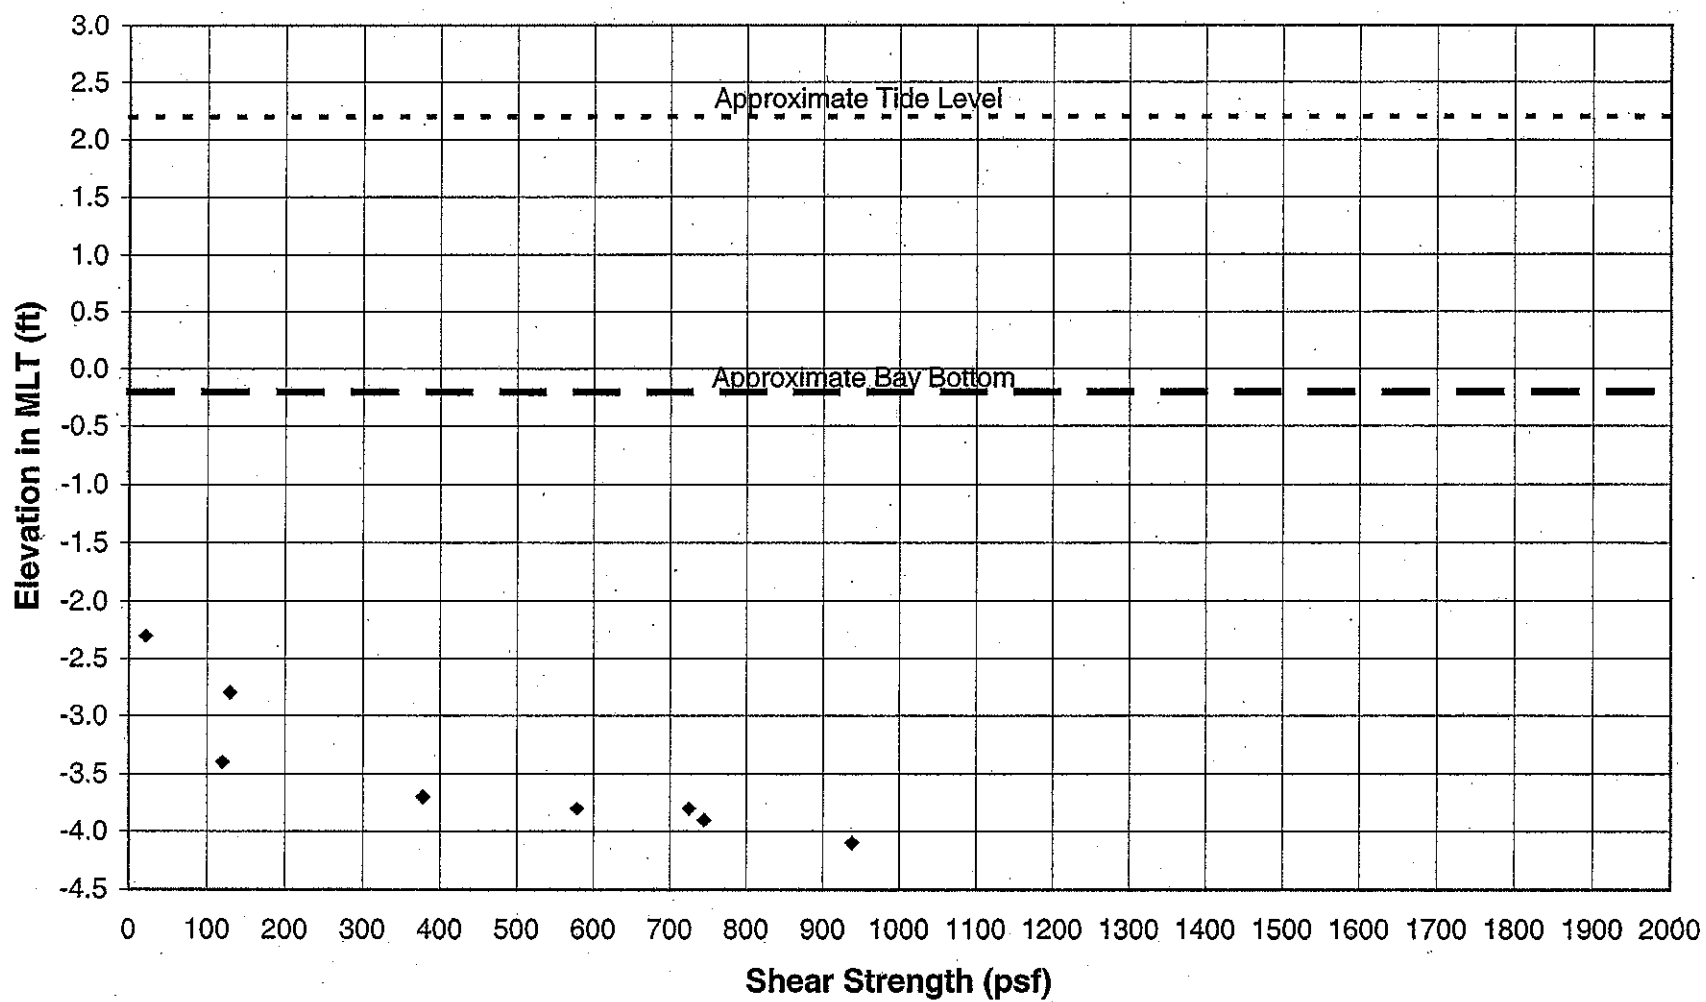
# Depth Vs. Shear Strength

♦ J13
