TEXAS GENERAL LAND OFFICE  
WEST GALVESTON ISLAND  
END OF SEAWALL NOURISHMENT  
EXHIBIT A – GALVESTON ANCHORAGE AREA

**ANCHORAGE BASIN SAND SOURCE INVESTIGATION**

Anchorage Basin  
Galveston Island, Texas

**PROJECT NAME:** Anchorage Basin Sand Source Investigation

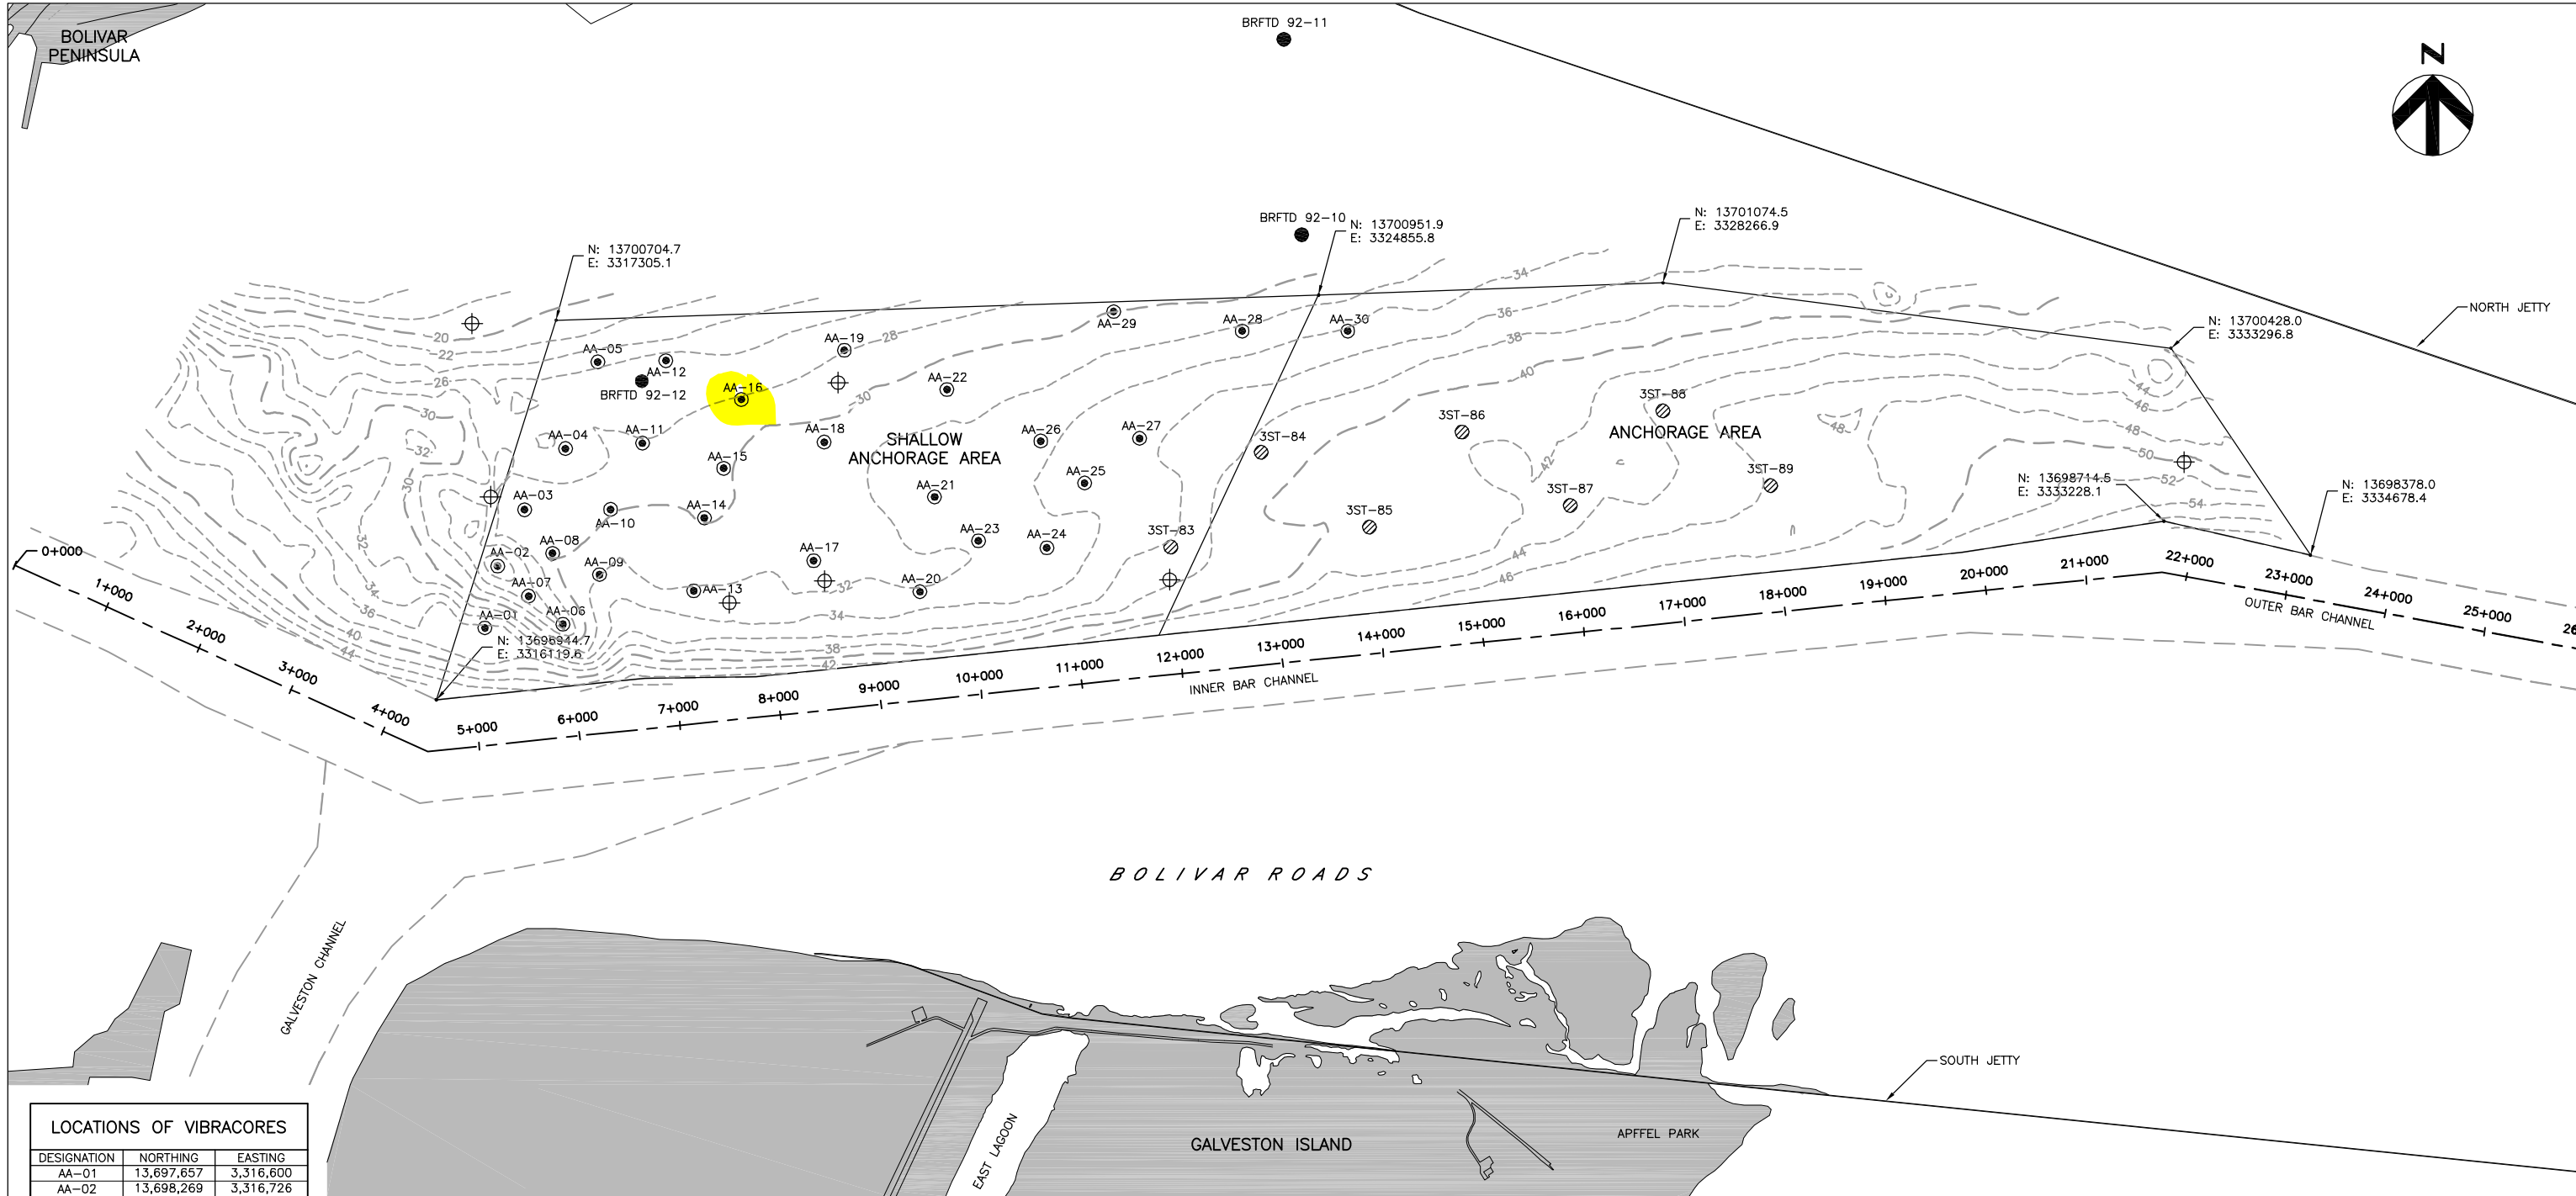
| FIGURE | EX A |

| LOCATIONS OF VIBRACORES | | |

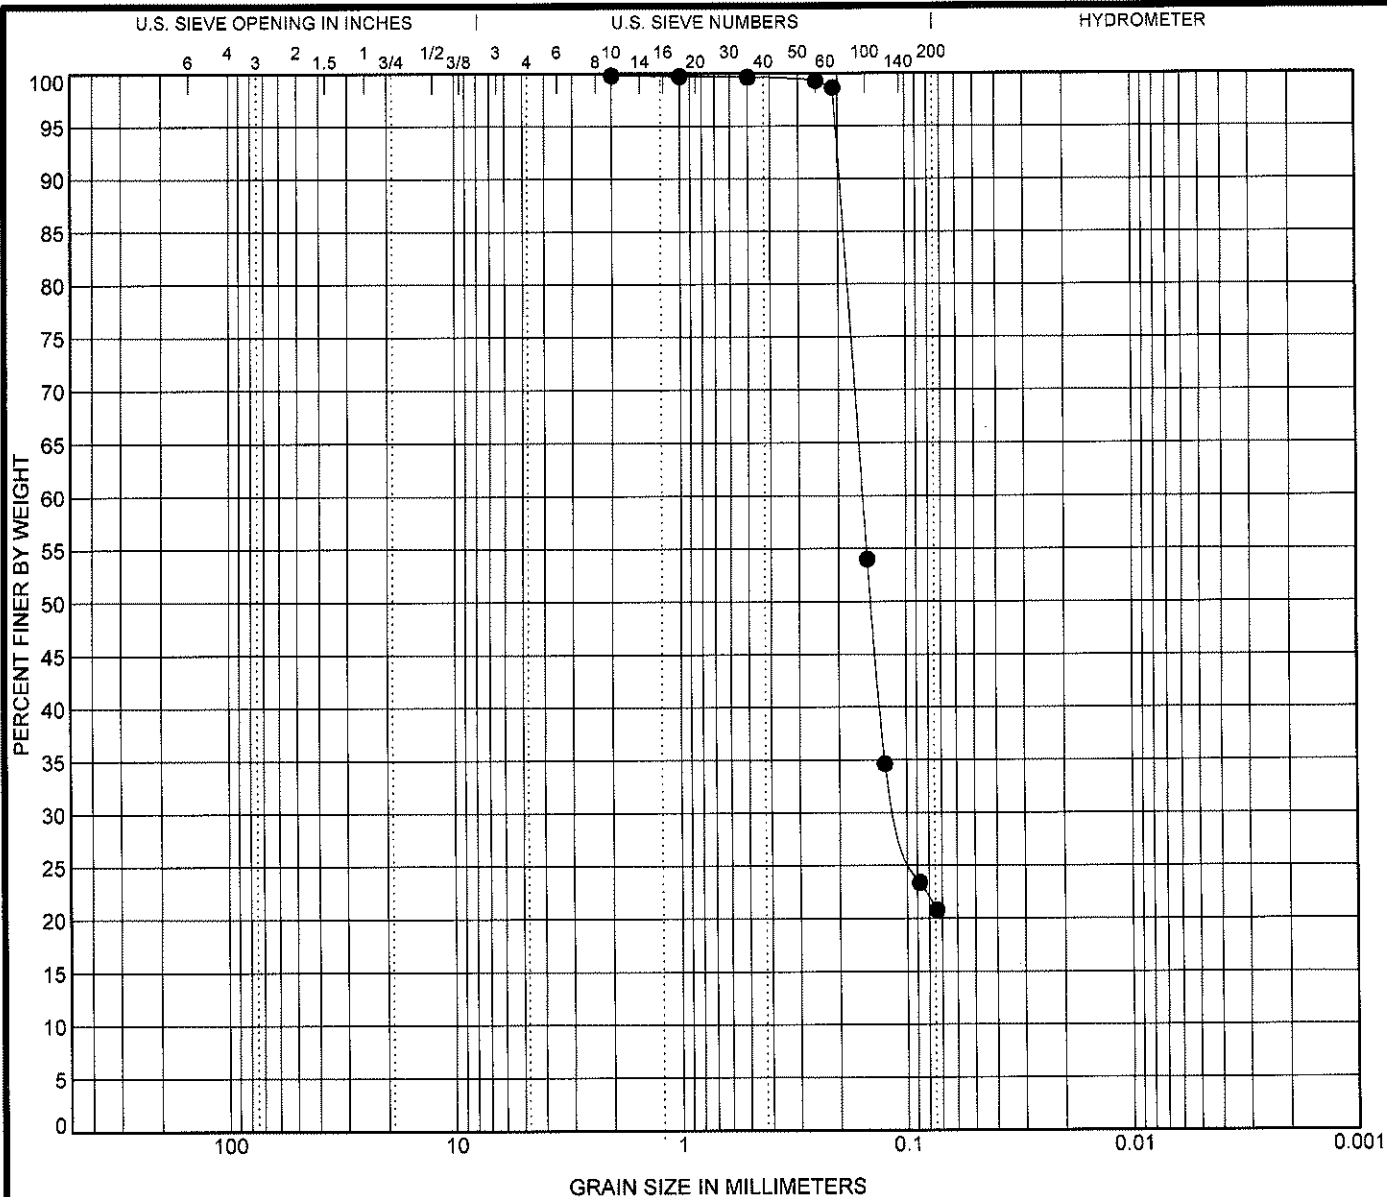
### GRAIN SIZE DISTRIBUTION

| Specimen ID | Depth | Classification | | | | LL | PL | PI | Cc | Cu |
|---|---|---|---|---|---|---|---|---|---|---|
| ● AA-16 | (-30' to -31' NAVD) | Borrow Area (-30' to -31' NAVD) | | | | | | | | |
| ● AA-16 | (-30' to -31' NAVD) | 2 | 0.156 | 0.108 | | 0.0 | | | | |

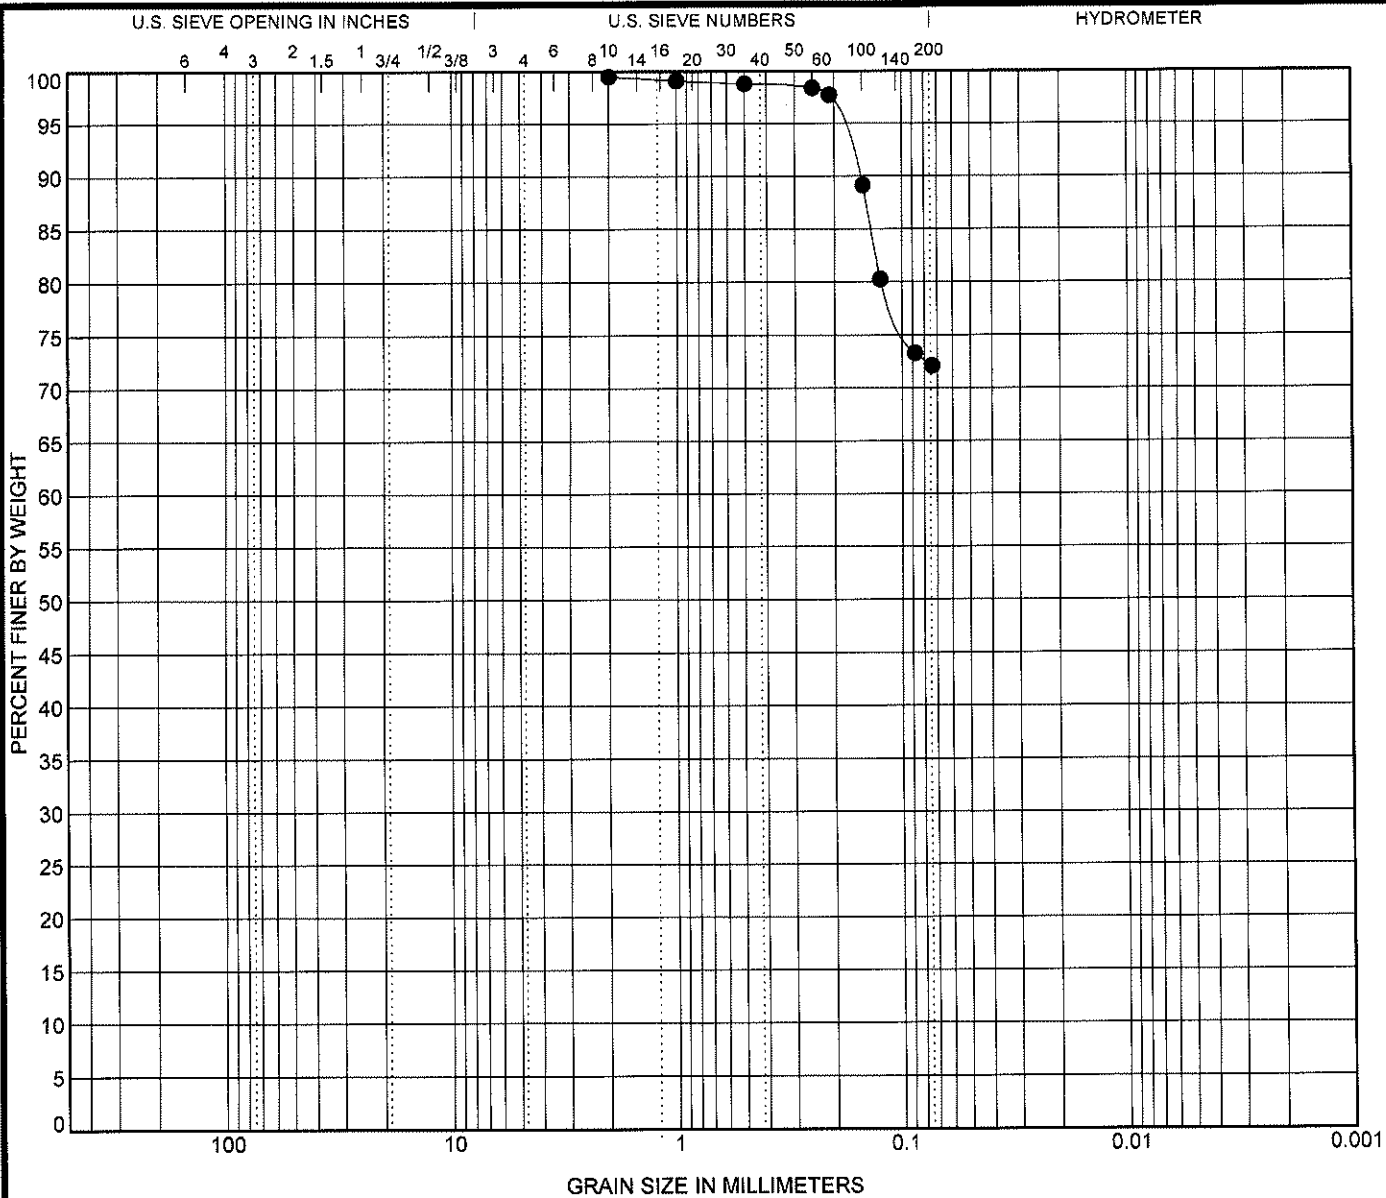
### GRAIN SIZE DISTRIBUTION

| Specimen ID | Depth | Classification | LL | PL | PI | Cc | Cu |
|---|---|---|---|---|---|---|---|
| ● AA-16 | (-32' to -33' NAVD) | Borrow Area (-32' to -33' NAVD) | | | | | |

| Specimen ID | Depth | D100 | D60 | D30 | D10 | %Gravel | %Sand | %Silt | %Clay |
|---|---|---|---|---|---|---|---|---|---|
| ● AA-16 | (-32' to -33' NAVD) | 2 | | | | 0.0 | | | |

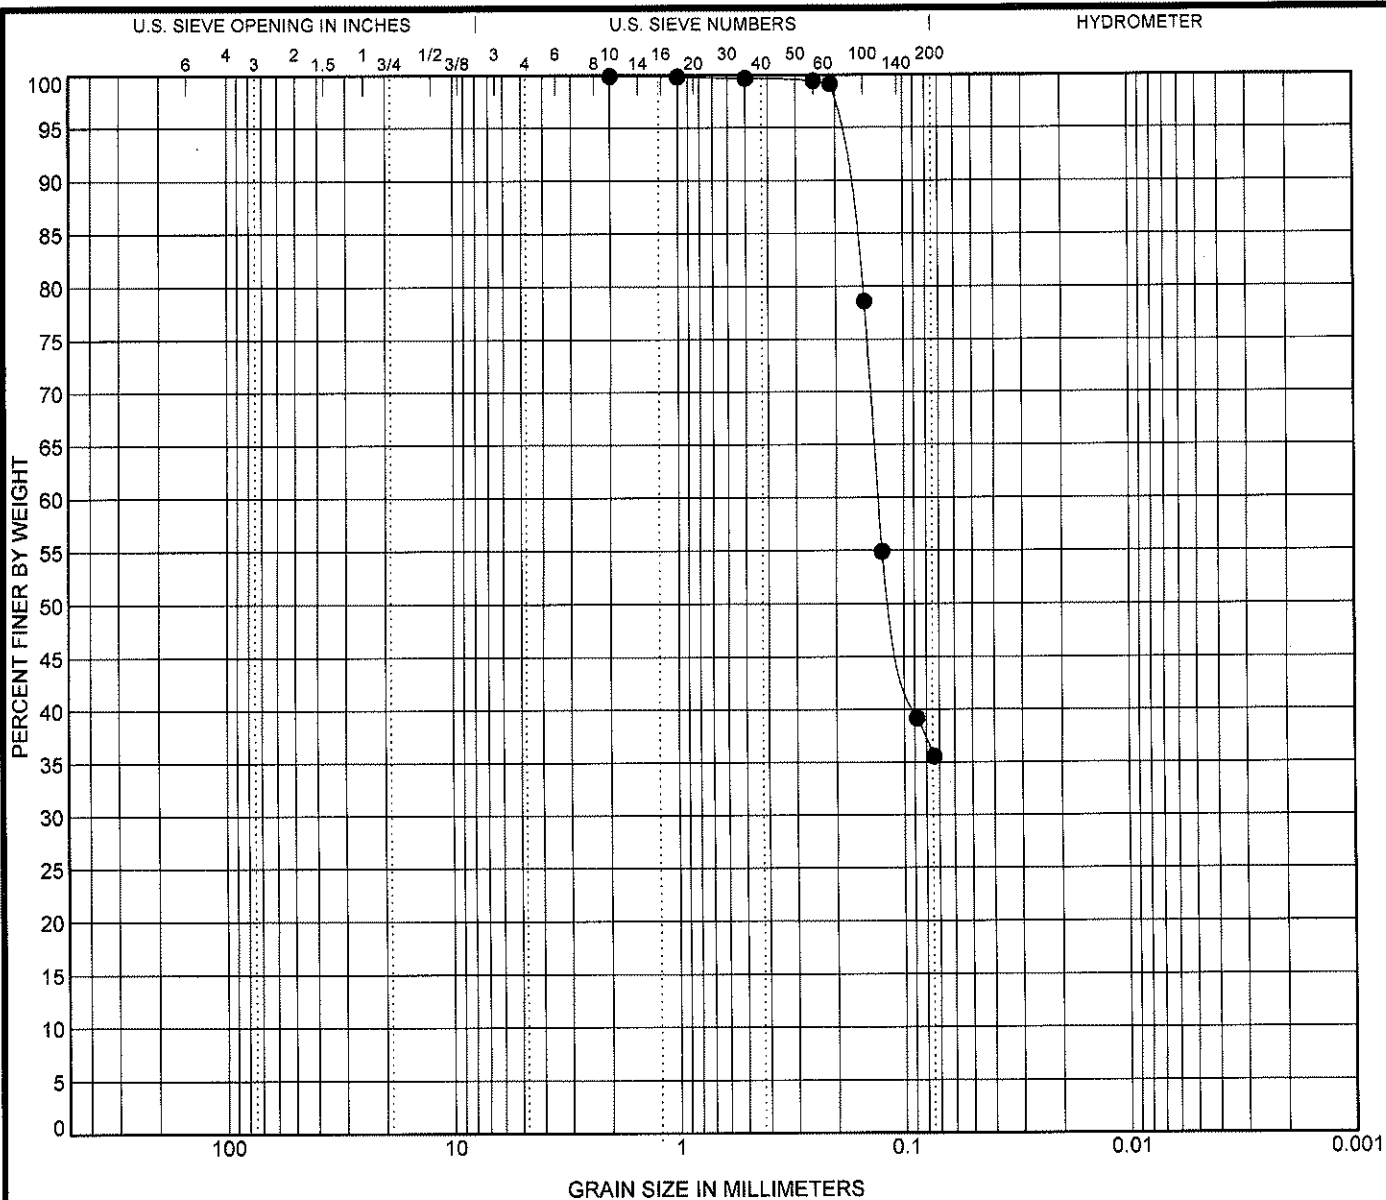
## GRAIN SIZE DISTRIBUTION

| Specimen ID | Depth | Classification | LL | PL | PI | Cc | Cu |
|---|---|---|---|---|---|---|---|
| ● AA-16 | (-36' to -37' NAVD) | Borrow Area (-36' to -37' NAVD) | | | | | |

| Specimen ID | Depth | D100 | D60 | D30 | D10 | %Gravel | %Sand | %Silt | %Clay |
|---|---|---|---|---|---|---|---|---|---|
| ● AA-16 | (-36' to -37' NAVD) | 2 | 0.13 | | | 0.0 | | | |

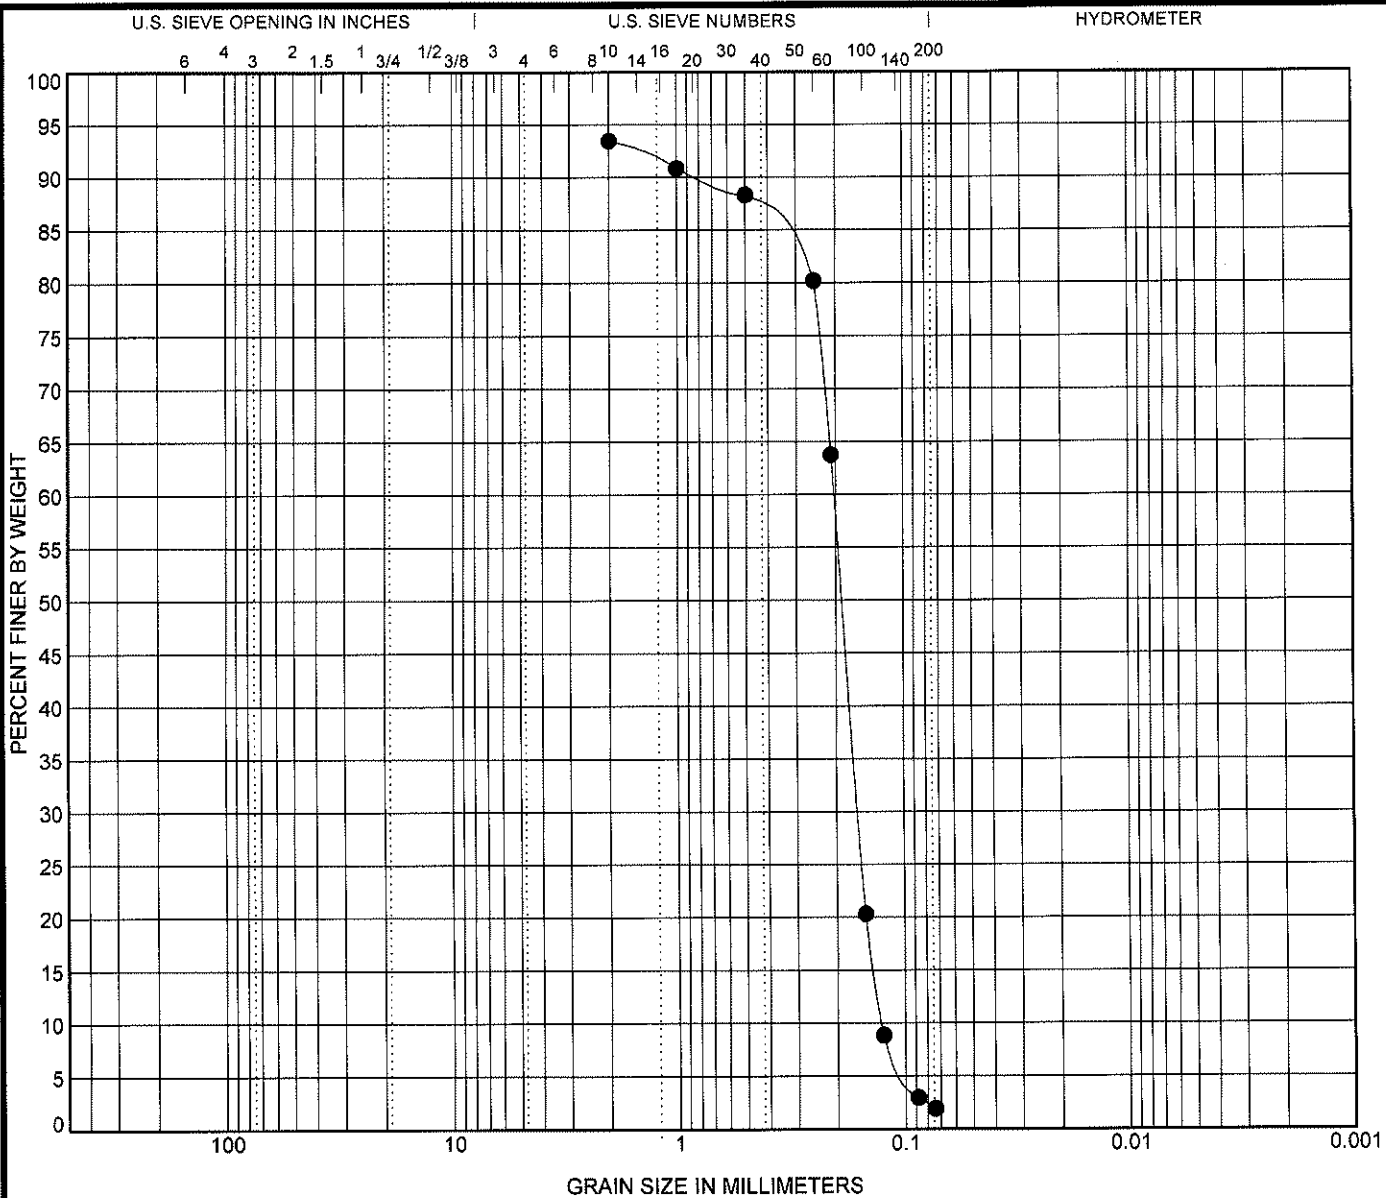
### GRAIN SIZE DISTRIBUTION

| Specimen ID | Depth | Classification | LL | PL | PI | Cc | Cu |
|---|---|---|---|---|---|---|---|
| ● AA-16 | (-39' to -40' NAVD) | Borrow Area (-39' to -40' NAVD) | | | | 1.00 | 1.60 |

| Specimen ID | Depth | D100 | D60 | D30 | D10 | %Gravel | %Sand | %Silt | %Clay |
|---|---|---|---|---|---|---|---|---|---|
| ● AA-16 | (-39' to -40' NAVD) | 2 | 0.204 | 0.161 | 0.127 | 0.0 | | | |
