**PROJECT NAME:** Anchorage Basin Sand Source Investigation

**BORING ID.:** AA-24

**DESCRIPTION:** Anchorage Basin Borrow Source Area

### GRAIN SIZE DISTRIBUTION

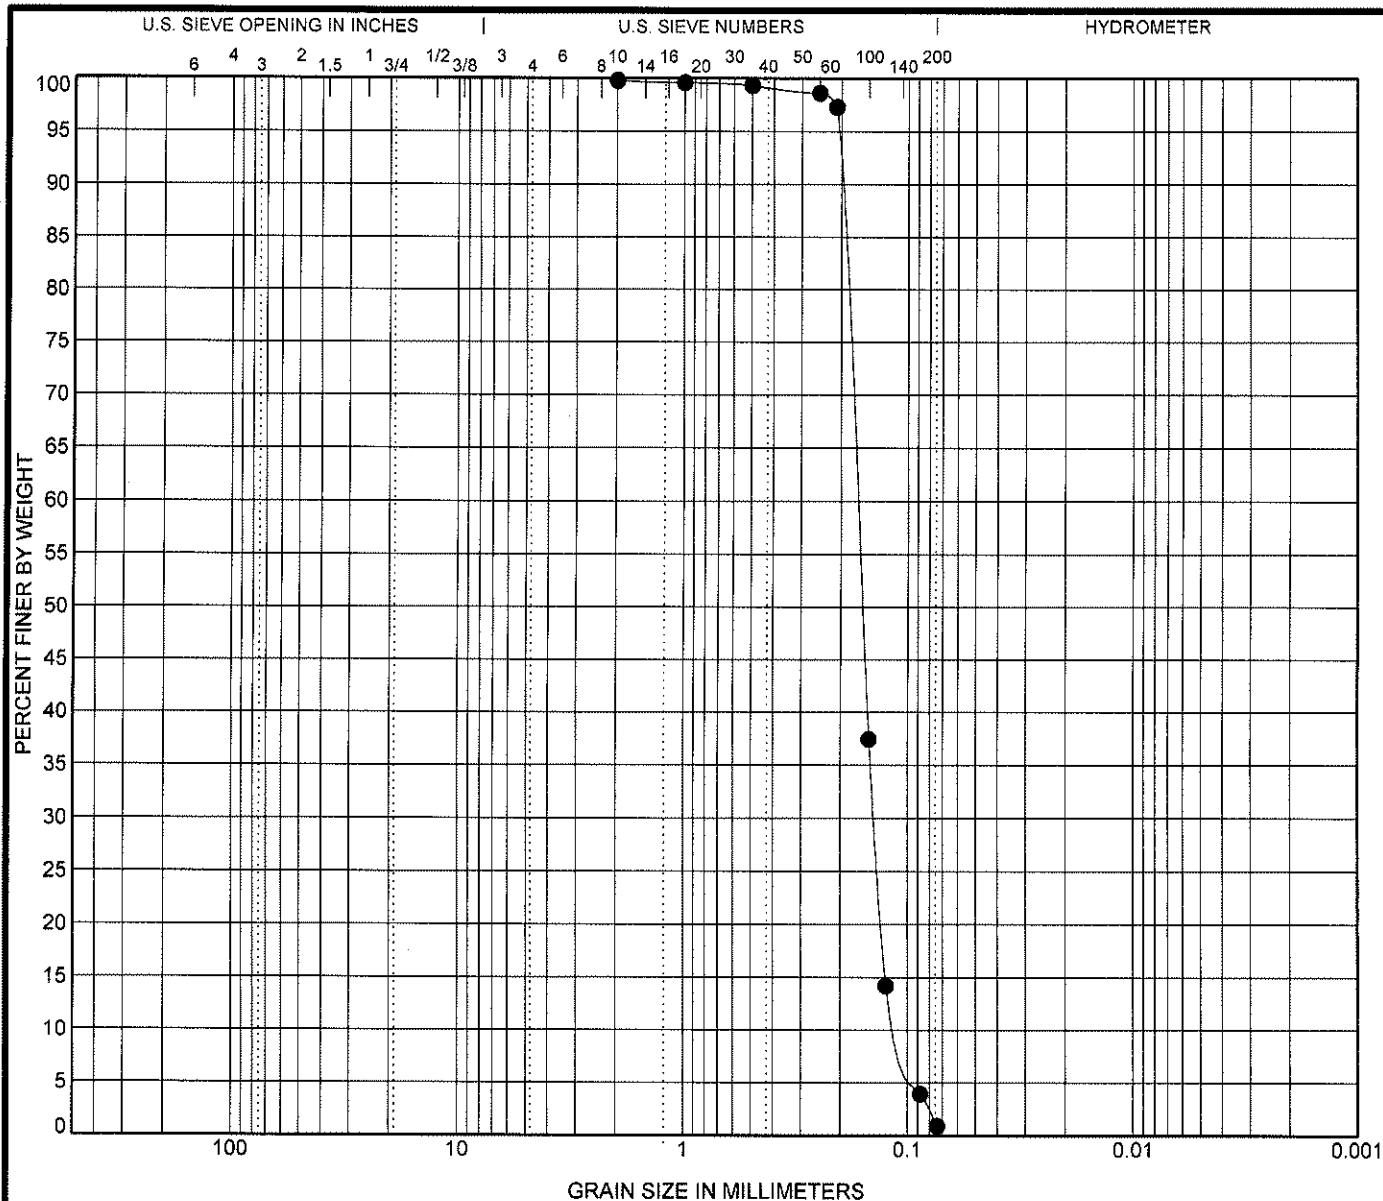
| Specimen ID | Depth | Classification | LL | PL | PI | Cc | Cu |
|---|---|---|---|---|---|---|---|
| ● AA-24 | (-33' to -34' NAVD) | Borrow Area (-33' to -34' NAVD) | | | | 1.08 | 1.57 |

| Specimen ID | Depth | D100 | D60 | D30 | D10 | %Gravel | %Sand | %Silt | %Clay |
|---|---|---|---|---|---|---|---|---|---|
| ● AA-24 | (-33' to -34' NAVD) | 2 | 0.17 | 0.141 | 0.108 | 0.0 | | | |

| ASTM<br>MESH | % FINER BY WEIGHT AFTER REMOVING SHELL | | | |
|---|---|---|---|---|
| MEDIAN GRAIN<br>SIZE (mm) | 0.17 | 0.08 | N/A | N/A |
| MEAN GRAIN SIZE<br>(mm) | 0.16 | N/A | N/A | N/A |
| SORTING ( $\sigma$ ) | 0.31 | N/A | N/A | N/A |

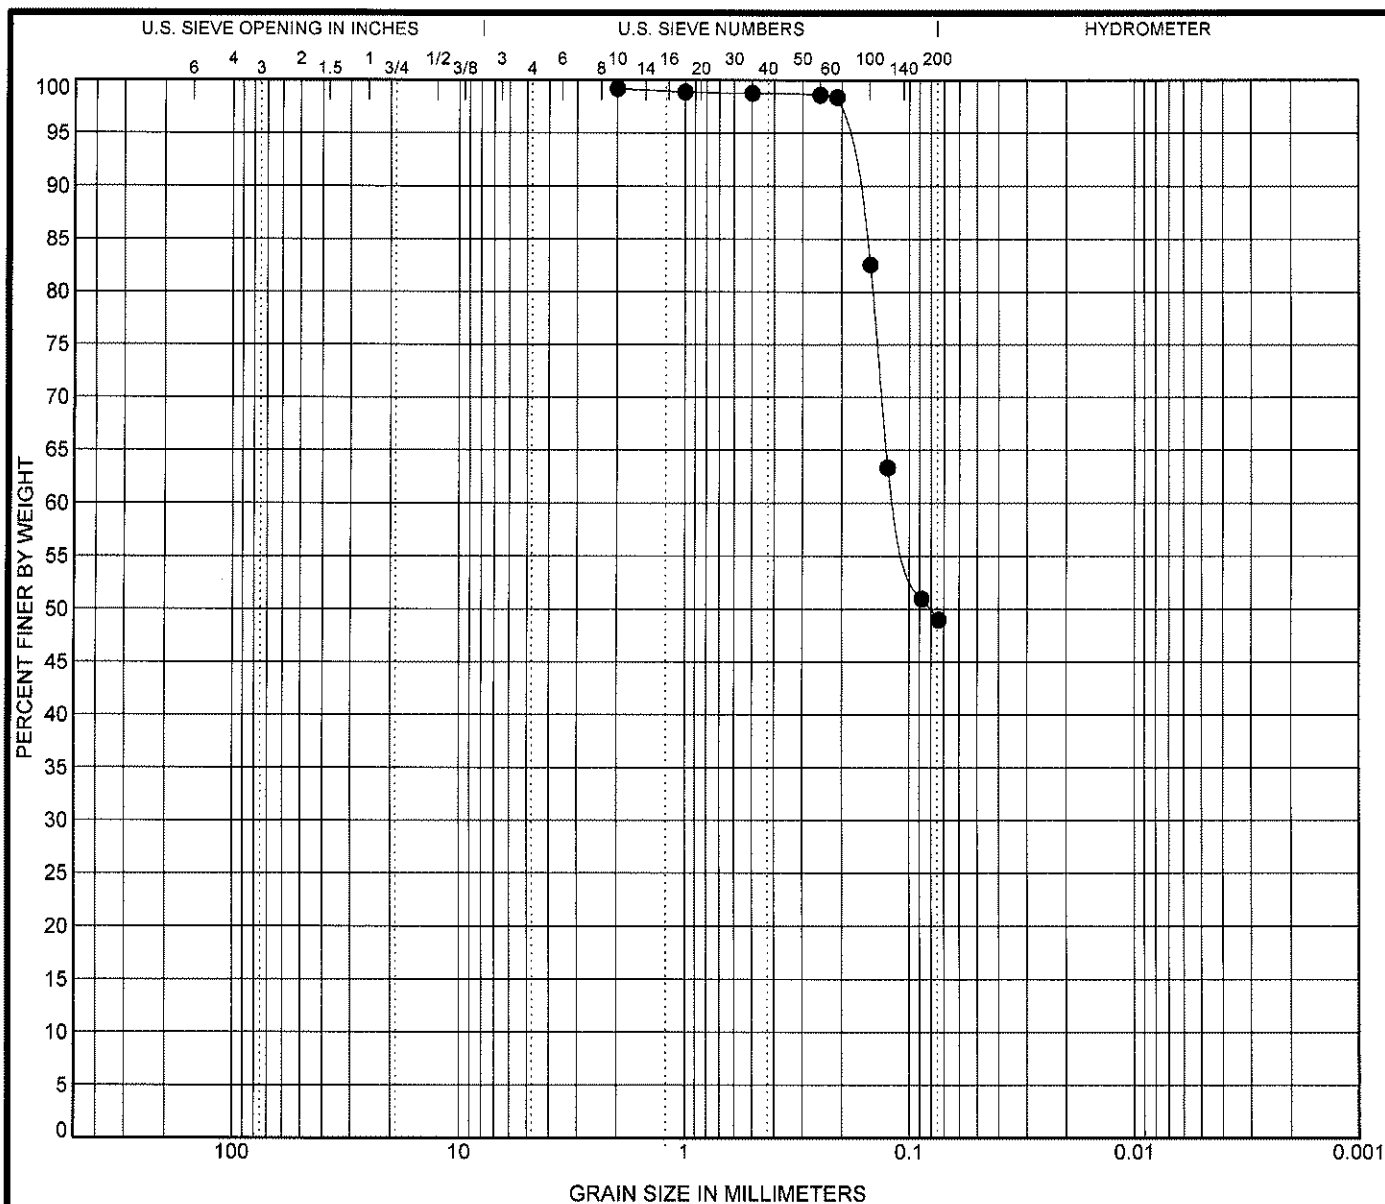
| Specimen ID | Depth | Classification | LL | PL | PI | Cc | Cu |
|---|---|---|---|---|---|---|---|
| ● AA-24 (-35' to -36' NAVD) | | Borrow Area (-35' to -36' NAVD) | | | | | |

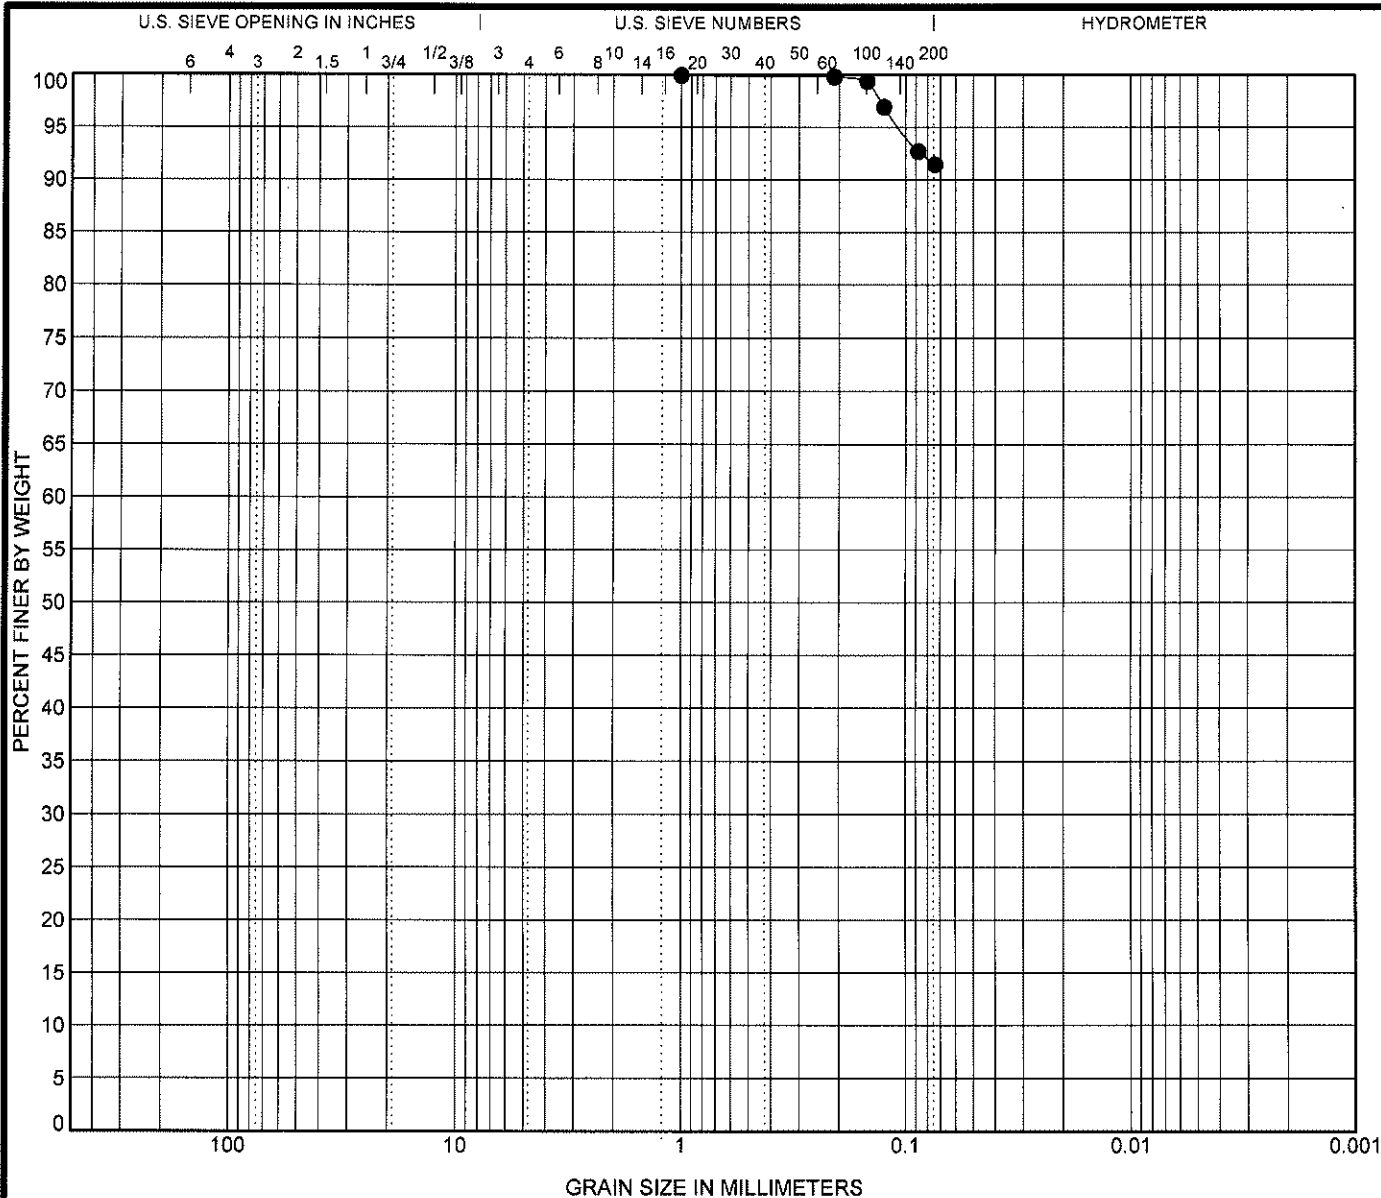
| Specimen ID | Depth | Classification | LL | PL | PI | Cc | Cu |
|---|---|---|---|---|---|---|---|
| ● AA-24 | (-38' to -39' NAVD) | Borrow Area (-38' to -39' NAVD) | | | | | |

| Specimen ID | Depth | D100 | D60 | D30 | D10 | %Gravel | %Sand | %Silt | %Clay |
|---|---|---|---|---|---|---|---|---|---|
| ● AA-24 | (-38' to -39' NAVD) | 1 | | | | 0.0 | | | |

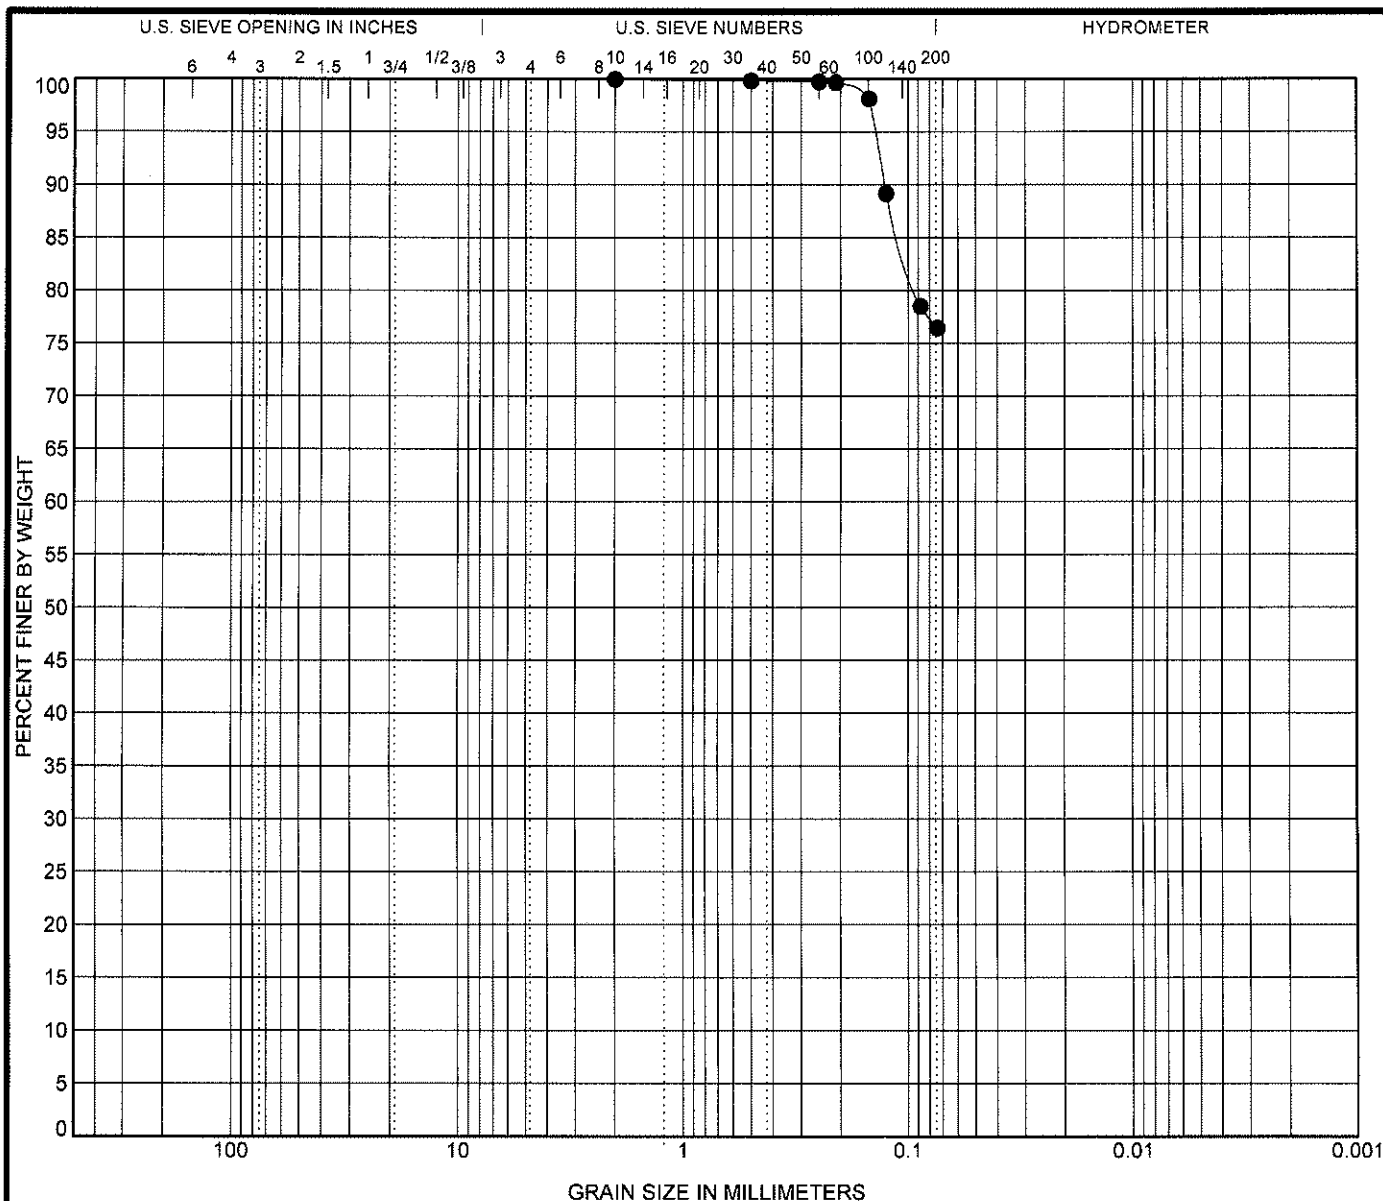
| Specimen ID | Depth | Classification | LL | PL | PI | Cc | Cu |
|---|---|---|---|---|---|---|---|
| ● AA-24 (-40' to -41' NAVD) | | Borrow Area (-40' to -41' NAVD) | | | | | |
