TEXAS GENERAL LAND OFFICE  
WEST GALVESTON ISLAND  
END OF SEAWALL NOURISHMENT  
EXHIBIT A – GALVESTON ANCHORAGE AREA

April 20, 2009  
Attn.: Mr. Daniel Heilman, P.E.  
RETL Job No.: G109112

**ANCHORAGE BASIN SAND SOURCE INVESTIGATION**

Anchorage Basin  
Galveston Island, Texas

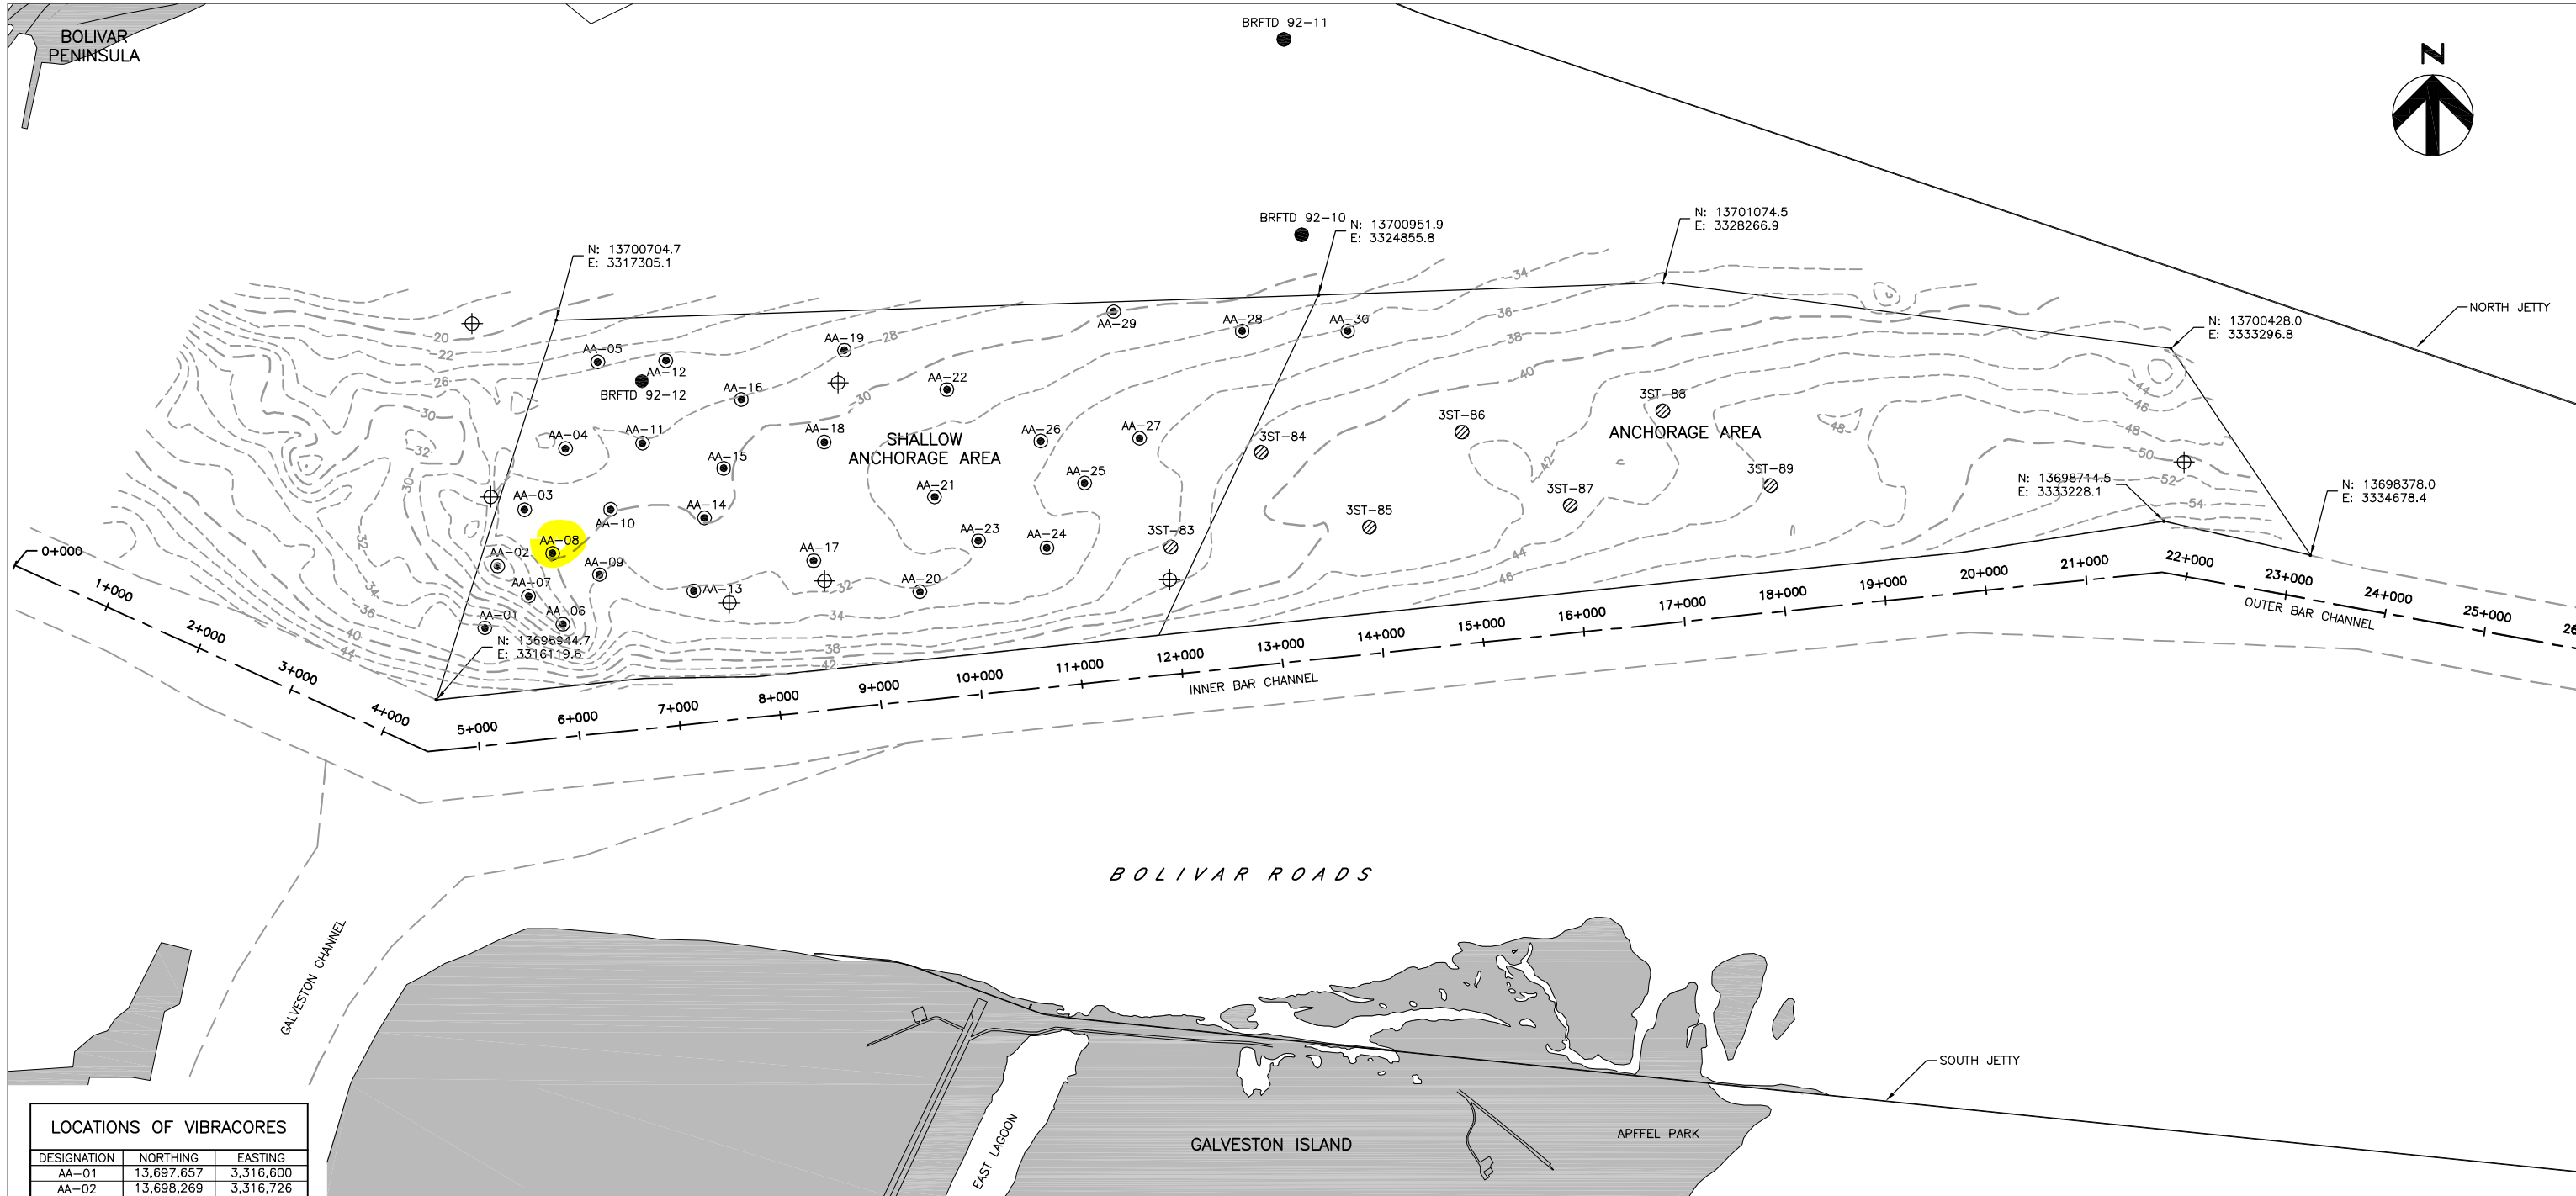
DATE  
4/22/09  
FIGURE  
EX A

| LOCATIONS OF VIBRACORES | | |

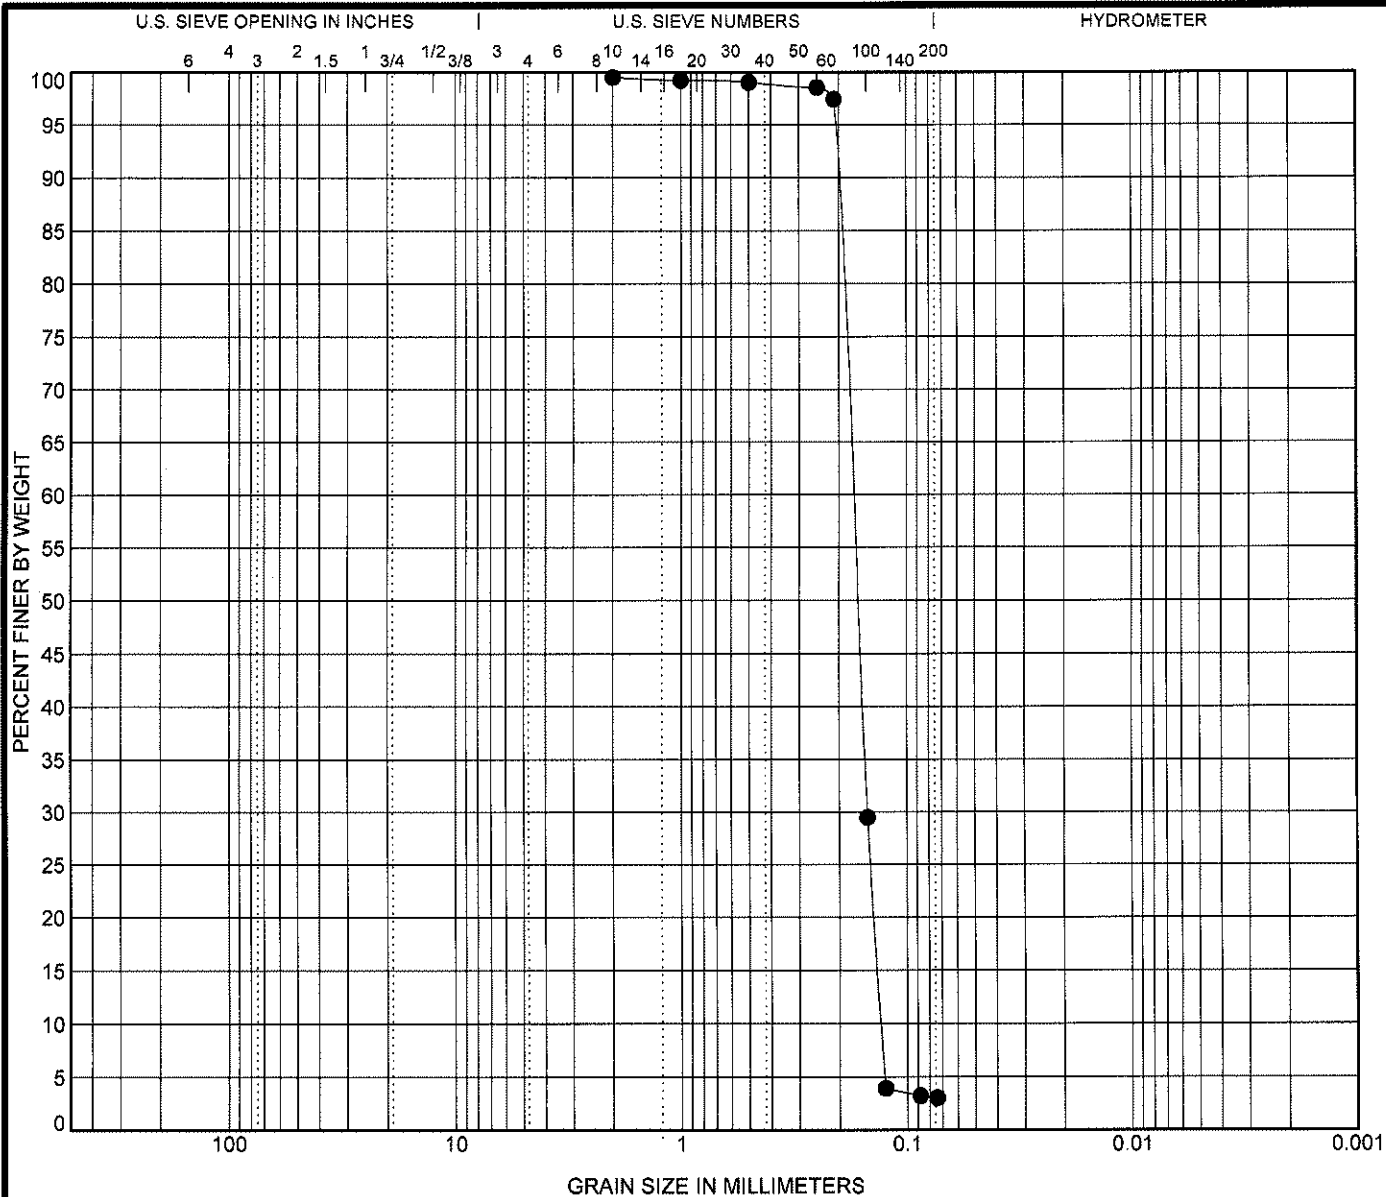
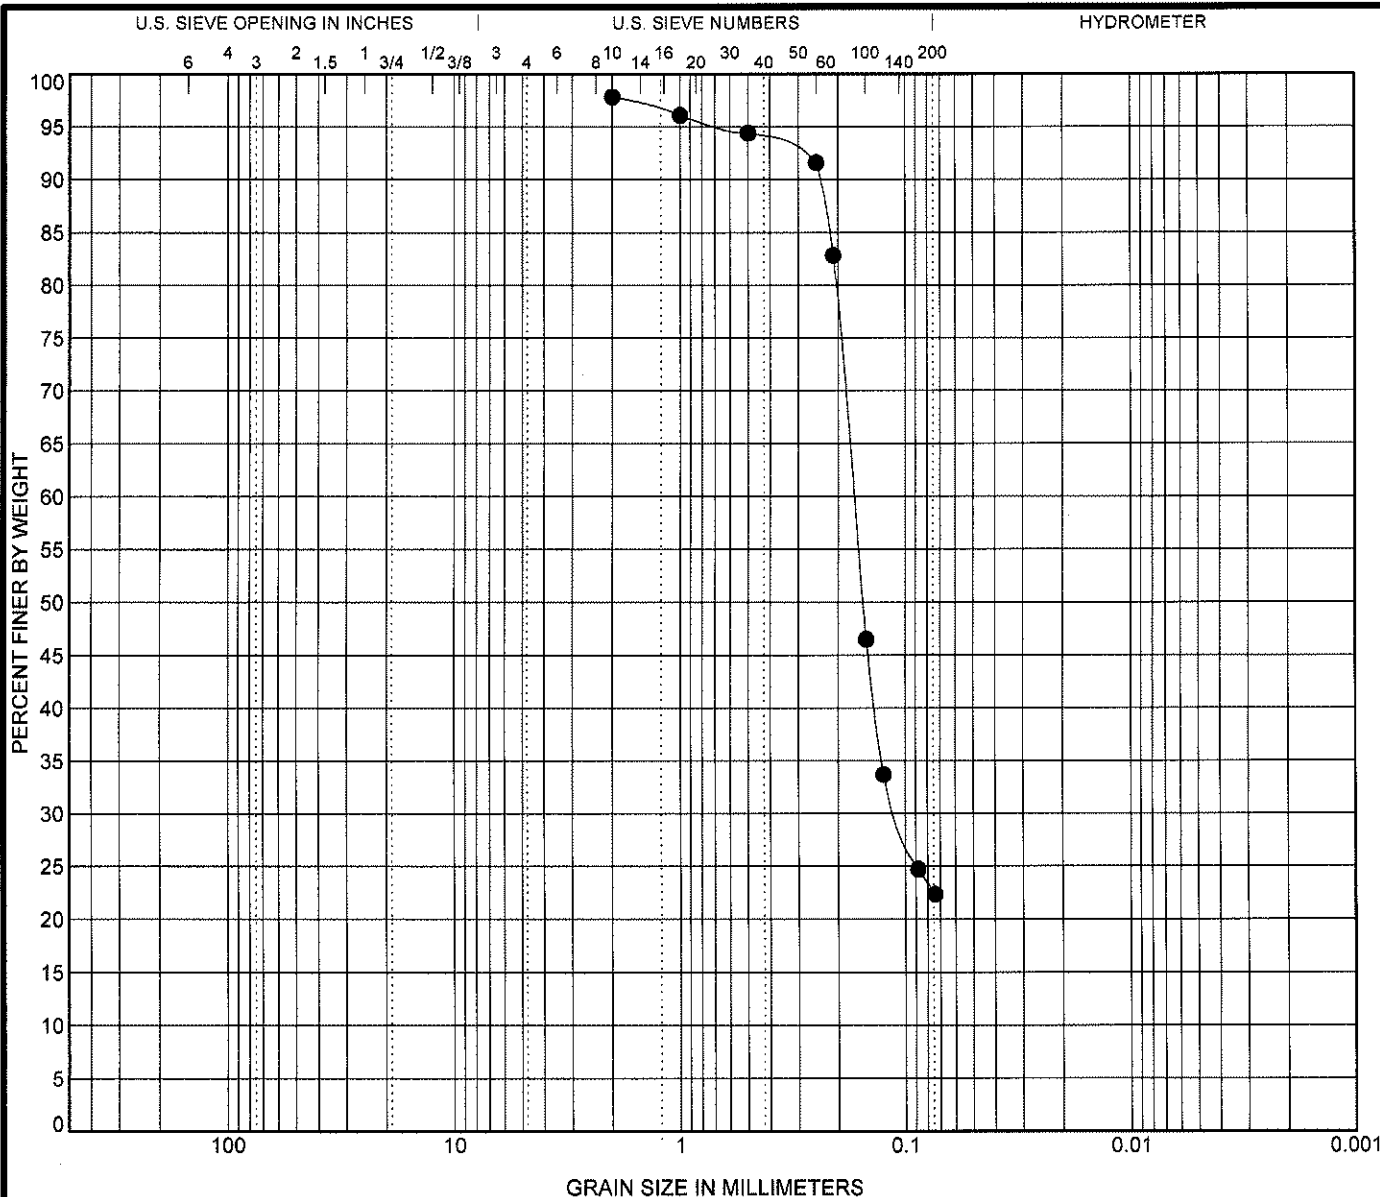
## GRAIN SIZE DISTRIBUTION

| Specimen ID | Depth | Classification | LL | PL | PI | Cc | Cu |
|---|---|---|---|---|---|---|---|
| ● AA-08 (-36' to -37' NAVD) | | Borrow Area (-36' to -37' NAVD) | | | | | |

| Specimen ID | Depth | D100 | D60 | D30 | D10 | %Gravel | %Sand | %Silt | %Clay |
|---|---|---|---|---|---|---|---|---|---|
| ● AA-08 (-36' to -37' NAVD) | | 2 | 0.169 | 0.108 | | 0.0 | | | |

| PERCENT SHELL BY WEIGHT (BASED ON #10 SIEVE) | | |
|---|---|---|
| -30' to -31' NAVD | -33' to -34' NAVD | -36' to -37' NAVD |
| 25.33 | 0.46 | 2.16 |

| ASTM<br>MESH | % FINER BY WEIGHT AFTER REMOVING SHELL | | |
|---|---|---|---|
| | -30' to -31' NAVD | -33' to -34' NAVD | -36' to -37' NAVD |
| MEDIAN GRAIN<br>SIZE (mm) | N/A | 0.17 | 0.17 |

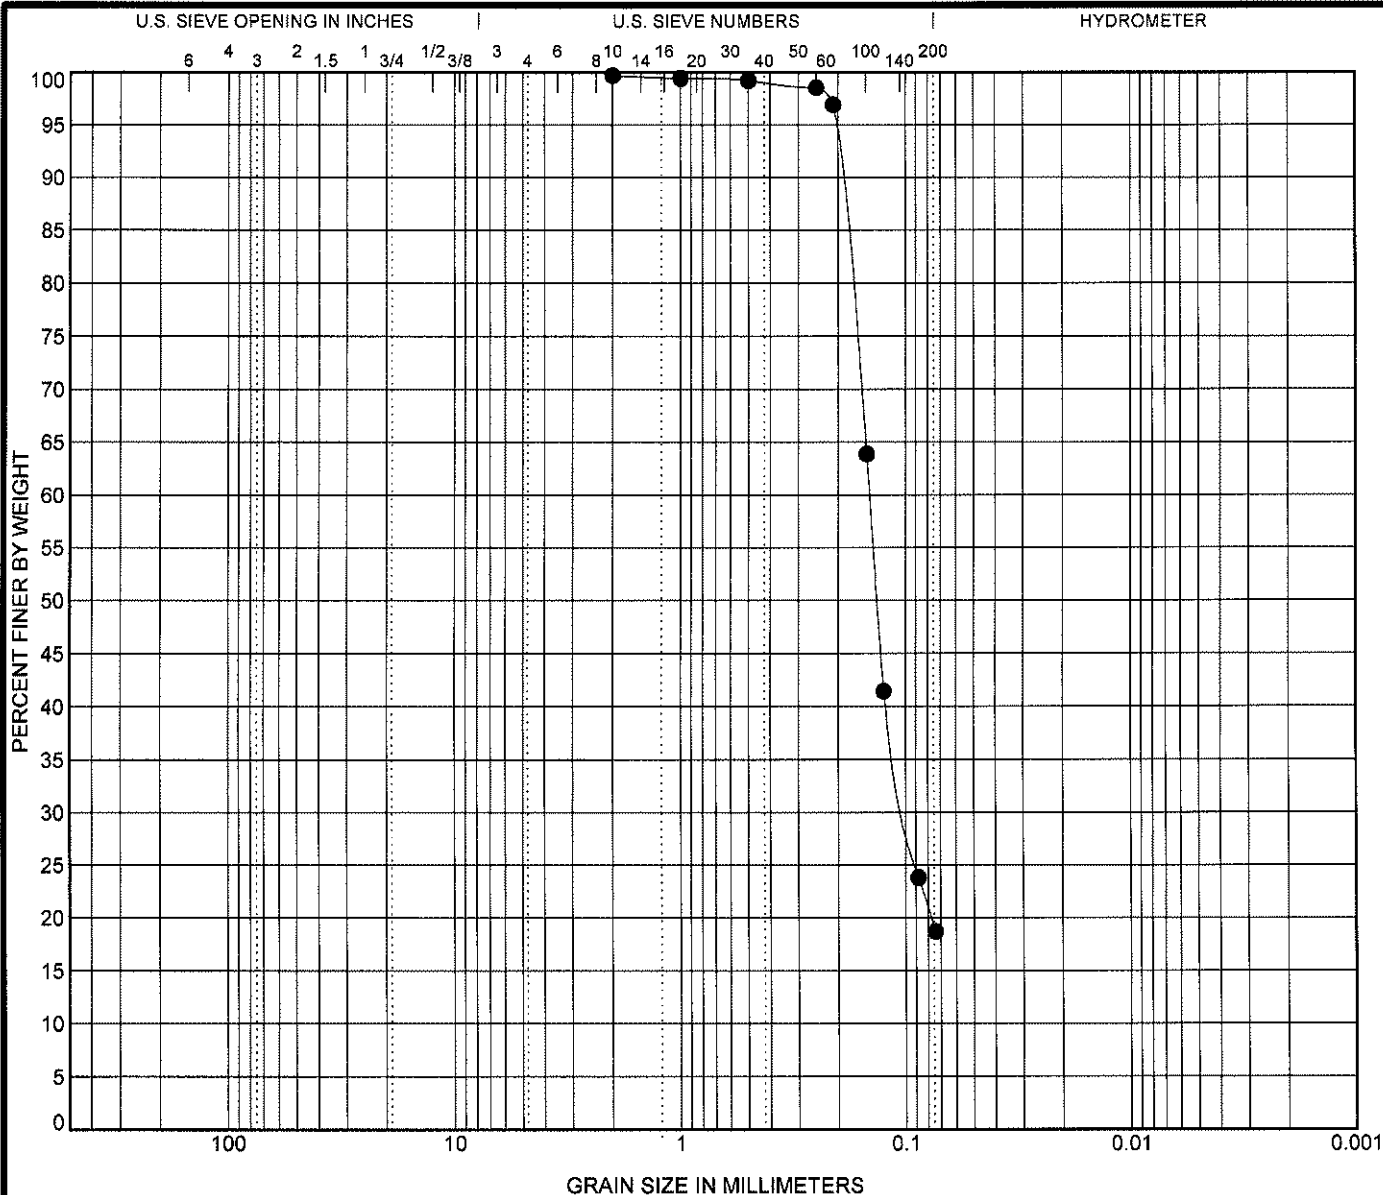
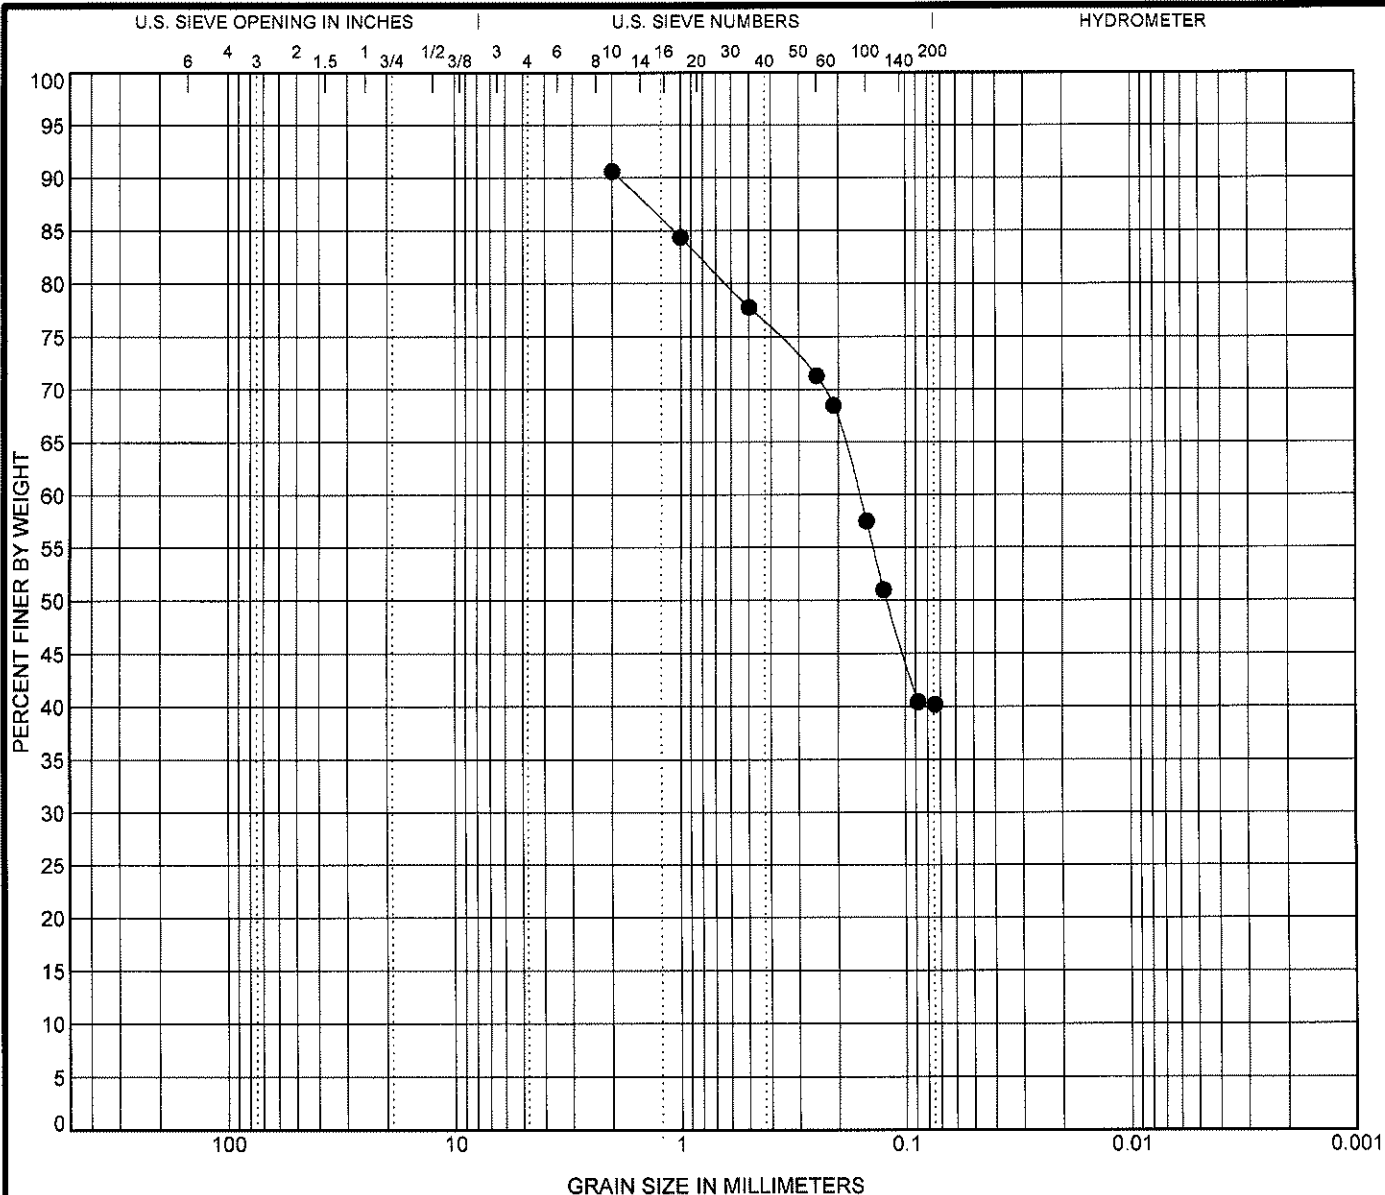
## GRAIN SIZE DISTRIBUTION

| Specimen ID | Depth | Classification | LL | PL | PI | Cc | Cu |
|---|---|---|---|---|---|---|---|
| ● AA-08 (-41' to -42' NAVD) | | Borrow Area (-41' to -42' NAVD) | | | | | |

| Specimen ID | Depth | D100 | D60 | D30 | D10 | %Gravel | %Sand | %Silt | %Clay |
|---|---|---|---|---|---|---|---|---|---|
| ● AA-08 (-41' to -42' NAVD) | | 2 | 0.161 | | | 0.0 | | | |

| ASTM<br>MESH | % FINER BY WEIGHT AFTER REMOVING SHELL | | |
|---|---|---|---|
| | -39' to -40' NAVD | -41' to -42' NAVD | -42' to -43' NAVD |
| MEDIAN GRAIN<br>SIZE (mm) | 0.15 | 0.13 | N/A |
